Facilities Assessment

Facility Condition Assessment

Indianapolis Public Library

February 27, 2023

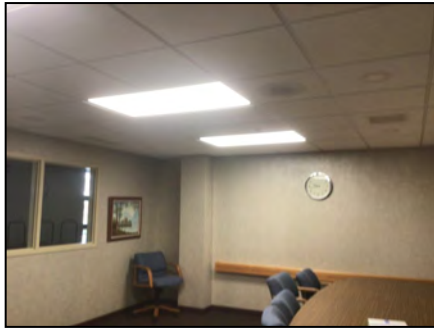
- It was reported that there was a complete renovation in 2002, excluding the plumbing systems, and the lighting was upgraded to LED in 2019.
- The fire alarm and detection system is beyond its recommended useful life.

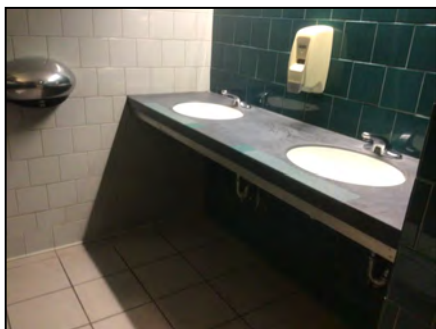
Vinyl wall covering is peeling. Carpet is stained. Restroom counters are stained. Some water damage noted around windows and on ceilings. Drywall corners are cracked on vaulted ceilings.

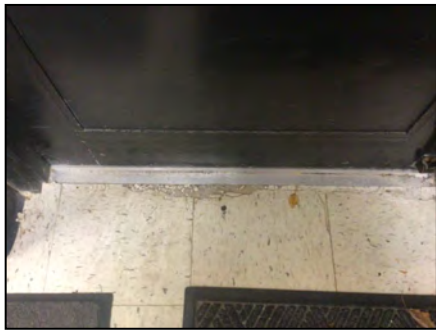
The metal and glazed doors were in good condition. The double-pane windows were in fair condition due to observed deteriorated window seals. The brick veneer walls were in good condition. The ~~modified bitumen~~ EPDM roof covering was beyond its recommended useful life.

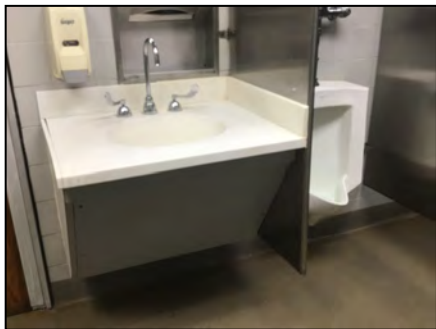
Stains on carpet and resinous flooring.

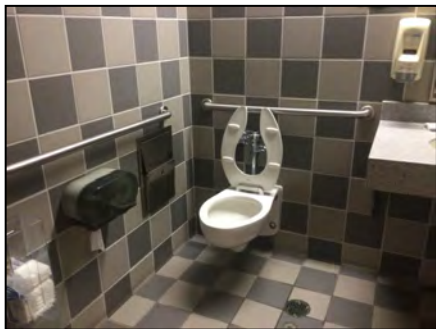
The carpet and ceramic tile floor finishes were in fair condition due to observed stains, and the vinyl tile floors were in poor condition due to observed damage. The vinyl and painted wall finishes were in good condition; however, the tile walls were in fair condition due to observed stains. The wood and suspended acoustical tile ceiling finishes were in good condition.
