Facilities Assessment

Facility Condition Assessment

Indianapolis Public Library

February 27, 2023

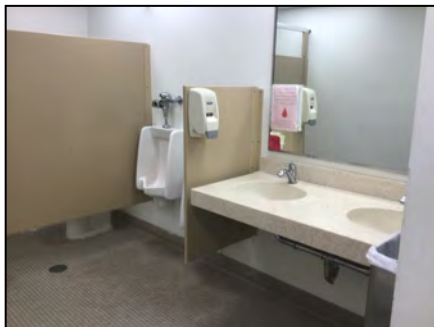
The carpet and ceramic tile floor finishes were in good condition; however, the vinyl tile floors were in poor condition due to observed damage. The painted and vinyl wall finishes were in good condition. The suspended acoustical tile and painted ceiling finishes were in good condition.

Stair treads are in fair condition due to discoloration. Vinyl wall covering is peeling. Interior door frames are scuffed and chipped. Paint on bottom of wood windows is flaking.

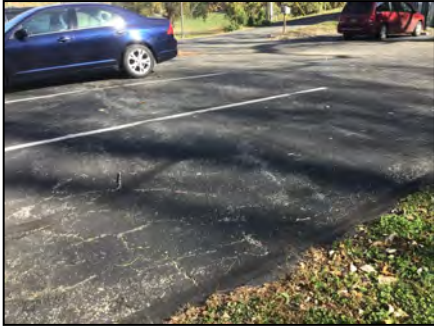
The asphalt pavements were in poor condition and in need of resealing as longitudinal and transverse cracking were observed throughout the pavement.

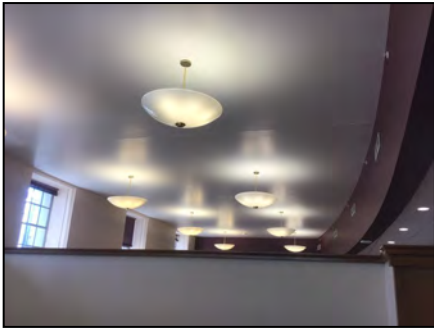
The incandescent, LED and fluorescent lighting was in good condition. The electrical branch wiring is within its recommended useful life. The service and distribution system was in good condition. The emergency and exit lighting is within its recommended useful life.

The fire alarm system is approaching end of life. The model installed is discontinued.

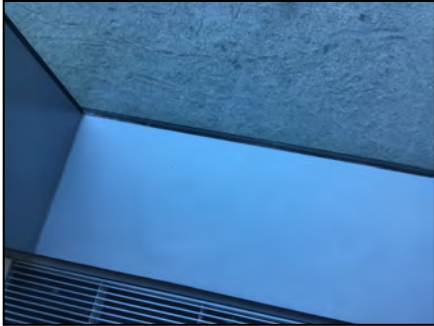
The metal, glazed and wooden doors were in good condition. The single-pane windows were in fair condition due to observed deteriorated window seals. The brick veneer and glazed walls were in good condition. The modified bitumen and glazed roof covering were within their recommended useful lives, however, a portion of the modified bitumen roof covering was beyond its recommended useful life.

Single glazed window panes are cracking. Glazed roofing reportedly leaks. Stone is in need of tuckpointing. Base of metal door frame rusting off of garden area.

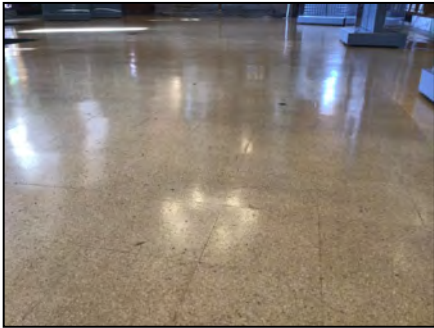
The carpet and finished concrete floor finishes were in good condition; however, the vinyl tile floors were in poor condition due to observed deterioration. The vinyl, oak veneer and tile wall finishes were in good condition. The painted and suspended acoustical tile ceiling finishes were in good condition.

Floor finishes are stained throughout with the exception of the new carpet on the 2nd floor. Vinyl wall covering is peeling in several areas. Admin area has stained ceiling tile. Ceramic tile needs repairs where new water coolers were installed. Admin area kitchen has stained floor. Decorative ceiling finish peeling.

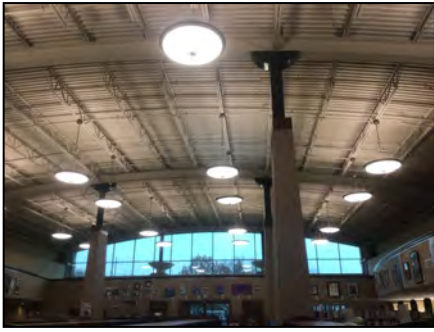
The LED lighting was in good condition. The electrical branch wiring is within its recommended useful life. The service and distribution system was in good condition. The emergency and exit lighting is beyond its recommended useful life.

The emergency and exit lighting are not beyond life if updated in 2017. Requires additional input from client.

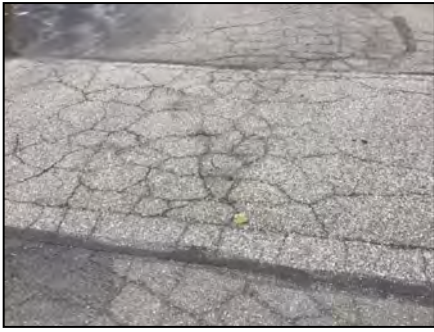
The asphalt pavements were in poor condition and in need of resurfacing as longitudinal cracking, transverse cracking, and degradation were observed throughout the pavement.

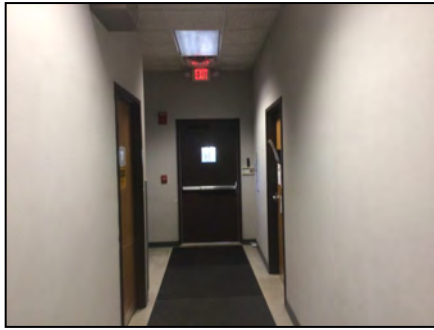
The fluorescent and incandescent lighting was in good condition. The electrical branch wiring is beyond its recommended useful life. The service and distribution system was in good condition. The emergency and exit lighting is beyond its recommended useful life.

Branch wiring is not beyond life.

Emergency and exit lighting age need to be determined, looks to be recent.

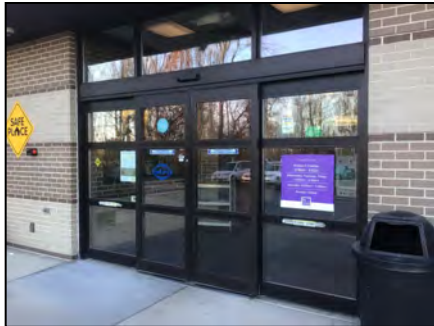
The metal doors were in good condition; however, the glazed doors were in fair condition due to observed malfunctioning hardware. The double-pane windows were in good condition. The brick veneer walls were in good condition. The standing seam metal panel roof covering was within its recommended useful life; however, the asphalt shingle roof was beyond its recommended useful life.

Exterior steel door frames are rusting. Sealant is deteriorated. Brick piers at exterior enclosure are deteriorated. Water in exterior access storage room.

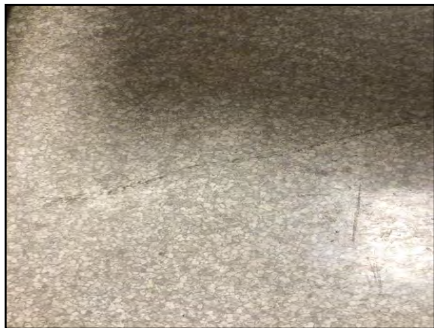
The ceramic tile floor finishes were in good condition; however, the carpet and resilient floors were in fair condition due to observed rippling and deterioration. The vinyl and painted wall finishes were in good condition. The suspended acoustical tile and adhered acoustical tile ceiling finishes were in fair condition due to observed stains.

Vinyl wall coverings are peeling. Seams cracking in gypsum ceilings.

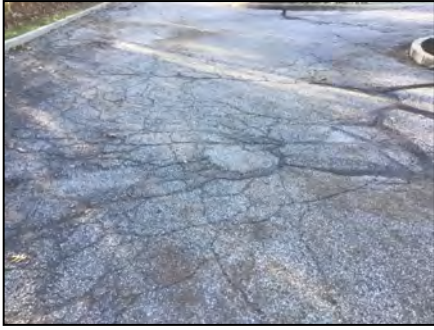
The asphalt pavements were in poor condition and in need of resurfacing as longitudinal cracking, transverse cracking, and degradation were observed throughout the pavement.

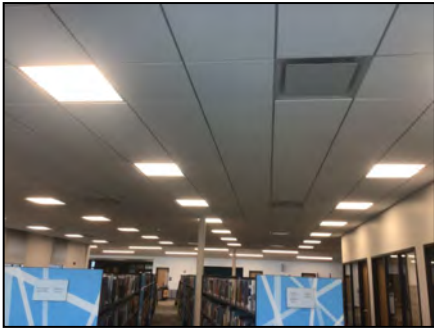
Electrical

The LED lighting was in good condition. The electrical branch wiring is within its recommended useful life. The service and distribution system was in good condition. The emergency and exit lighting is within its recommended useful life.

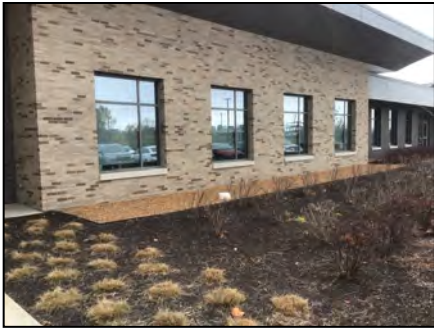
Exterior Enclosure

The glazed and metal doors were in good condition. The double-pane windows were in good condition. The brick veneer walls were in good condition. The single-ply membrane roof covering was within its recommended useful life.

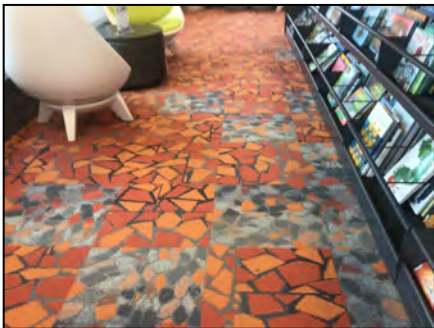
Interiors

The ceramic tile, carpet and laminate wood floor finishes were in good condition. The painted wall finishes were in good condition. The suspended acoustical tile ceiling finishes were in good condition.

Carpeting has stains. Staining on some ceiling tiles.

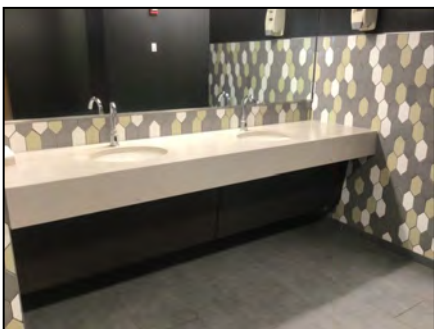
Plumbing

The porcelain and automated plumbing fixtures were in good condition. The domestic water distribution system is within its recommended useful life. The sanitary waste system is within its recommended useful life.

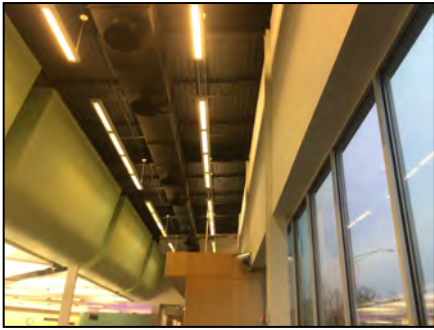
Electrical

The fluorescent lighting was in good condition. The electrical branch wiring is within its recommended useful life. The service and distribution system was in good condition. The emergency and exit lighting is within its recommended useful life.

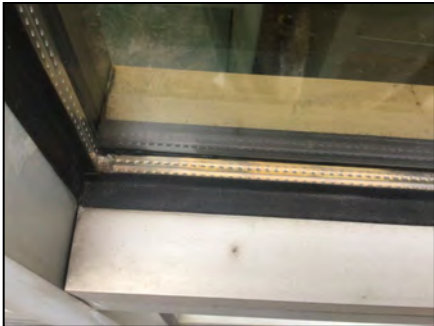
Exterior Enclosure

The glazed and metal doors were in good condition. The double-pane windows were in fair condition due to observed deteriorated window seals. The CMU walls were in good condition. ~~The modified bitumen~~ roof covering was within its recommended useful life. TPO/PVC roof.

The bottom of the exterior hollow metal frames are rusting. Some fiber cement panels are broken. The bottom of steel columns are rusting.

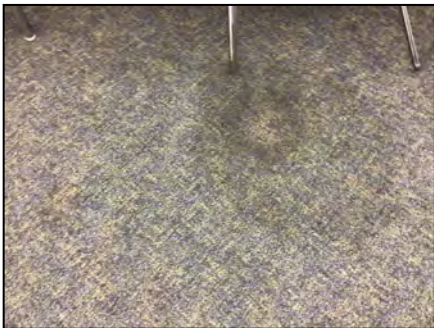
Interiors

The finished concrete floor finishes were in good condition; however, the carpet floors were in fair condition due to observed stains. The vinyl and painted wall finishes were in good condition. The suspended acoustical tile and painted ceiling finishes were in good condition.

Flooring in the restroom was stained and cracked at the perimeter. Steel lavatory supports are rusting. Grout on wall tile is stained. Toilet partition has makeshift support. Vinyl wall covering is starting to peel.

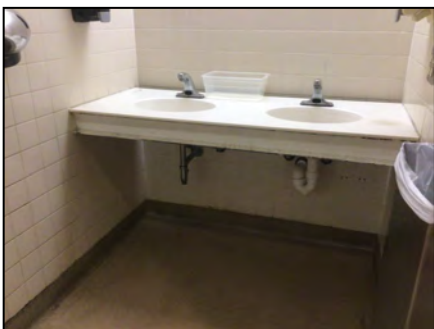
Plumbing

The porcelain and automated plumbing fixtures were in good condition. The domestic water distribution system is within its recommended useful life. The sanitary waste system is within its recommended useful life.

Water heater is in good condition.

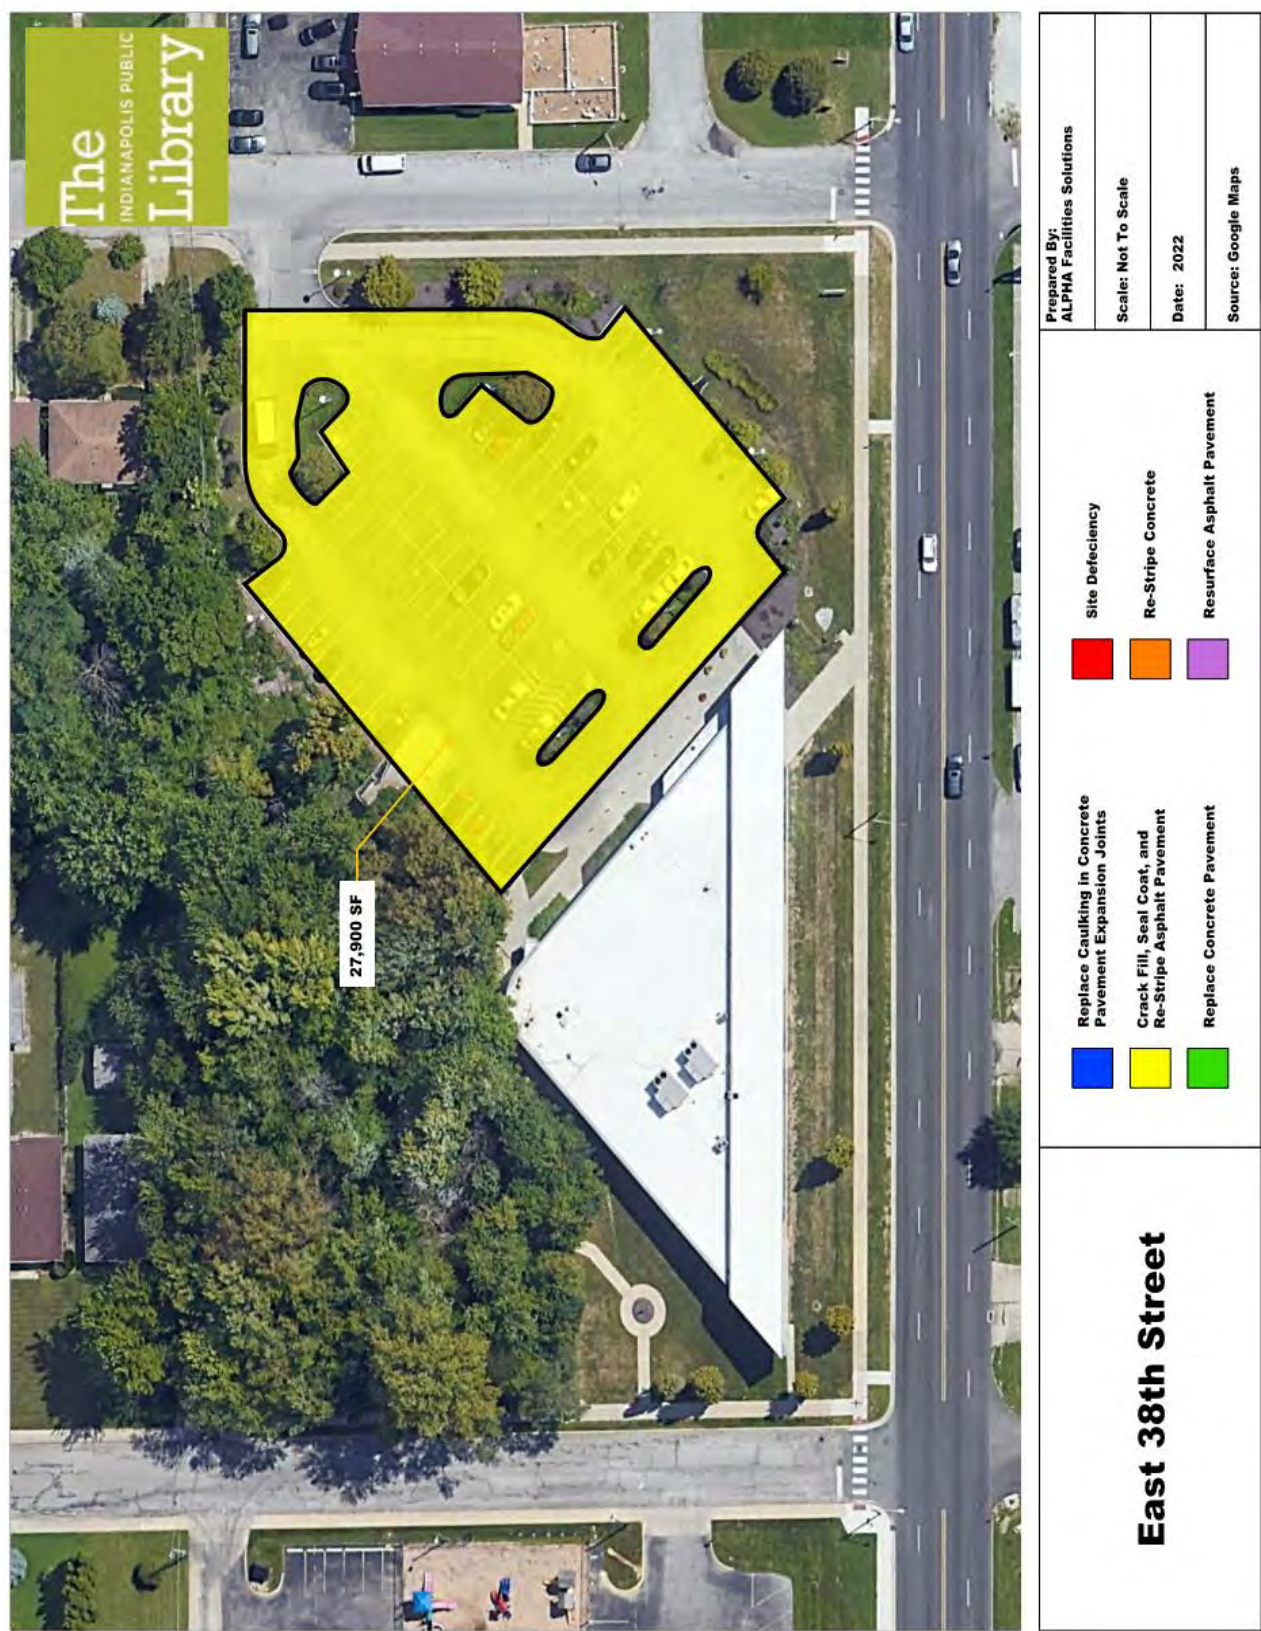
Figure 9. Site and Infrastructure Deficiencies Markup: East 38th Street

- The asphalt pavements were in poor condition and in need of resealing as longitudinal and transverse cracking were observed throughout the pavement.

Asset Description	Corrective Action	Notes	Priority	Current Needs	Year
Vehicular Pavements	Crack Fill, Seal Coat, and Restripe Asphalt Pavements	27900 SF @ \$1.2 Per SF	Low	\$33,480	2022
			Total 2022 Needs	\$33,480

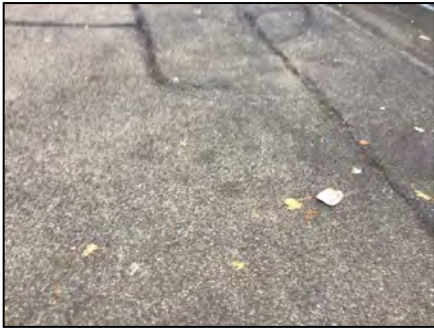
Site Infrastructure

The asphalt pavements were in poor condition and in need of resealing as longitudinal and transverse cracking were observed throughout the pavement.

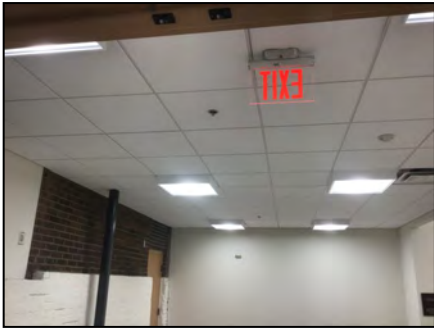
Electrical

The LED lighting was in good condition. The electrical branch wiring is within its recommended useful life. The service and distribution system was in good condition. The emergency and exit lighting is within its recommended useful life.

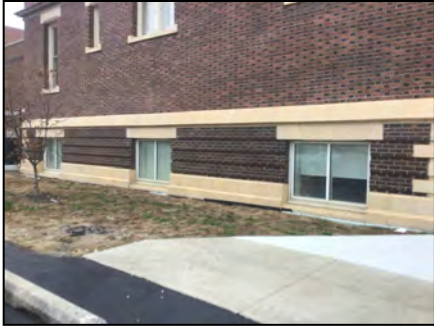
Exterior Enclosure

The metal and wooden doors were in good condition. The double-pane windows were in good condition. The brick veneer walls were in good condition. The asphalt shingle and single-ply membrane roof covering are within their recommended useful lives.

Some masonry repairs are needed at the base of the original building. Bottom of exterior hollow metal doors and frames is rusting. Wood doors need refinishing. A roof drain on the front of the building is clogged. Access to this drain is unsafe. Downspouts on back of building drain to the sidewalk causing slick surfaces in the winter.

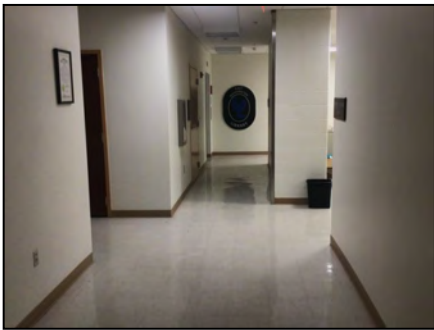
Interiors

The laminate wood and vinyl tile floor finishes were in good condition. The painted wall finishes were in good condition. The suspended acoustical tile ceiling finishes were in good condition.

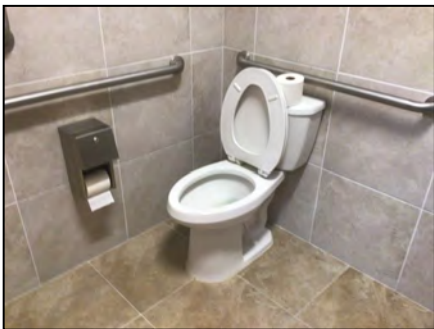
Plumbing

The porcelain and manual plumbing fixtures were in good condition. The domestic water distribution system is within its recommended useful life. The sanitary waste system is within its recommended useful life.

Water heater is in good condition.

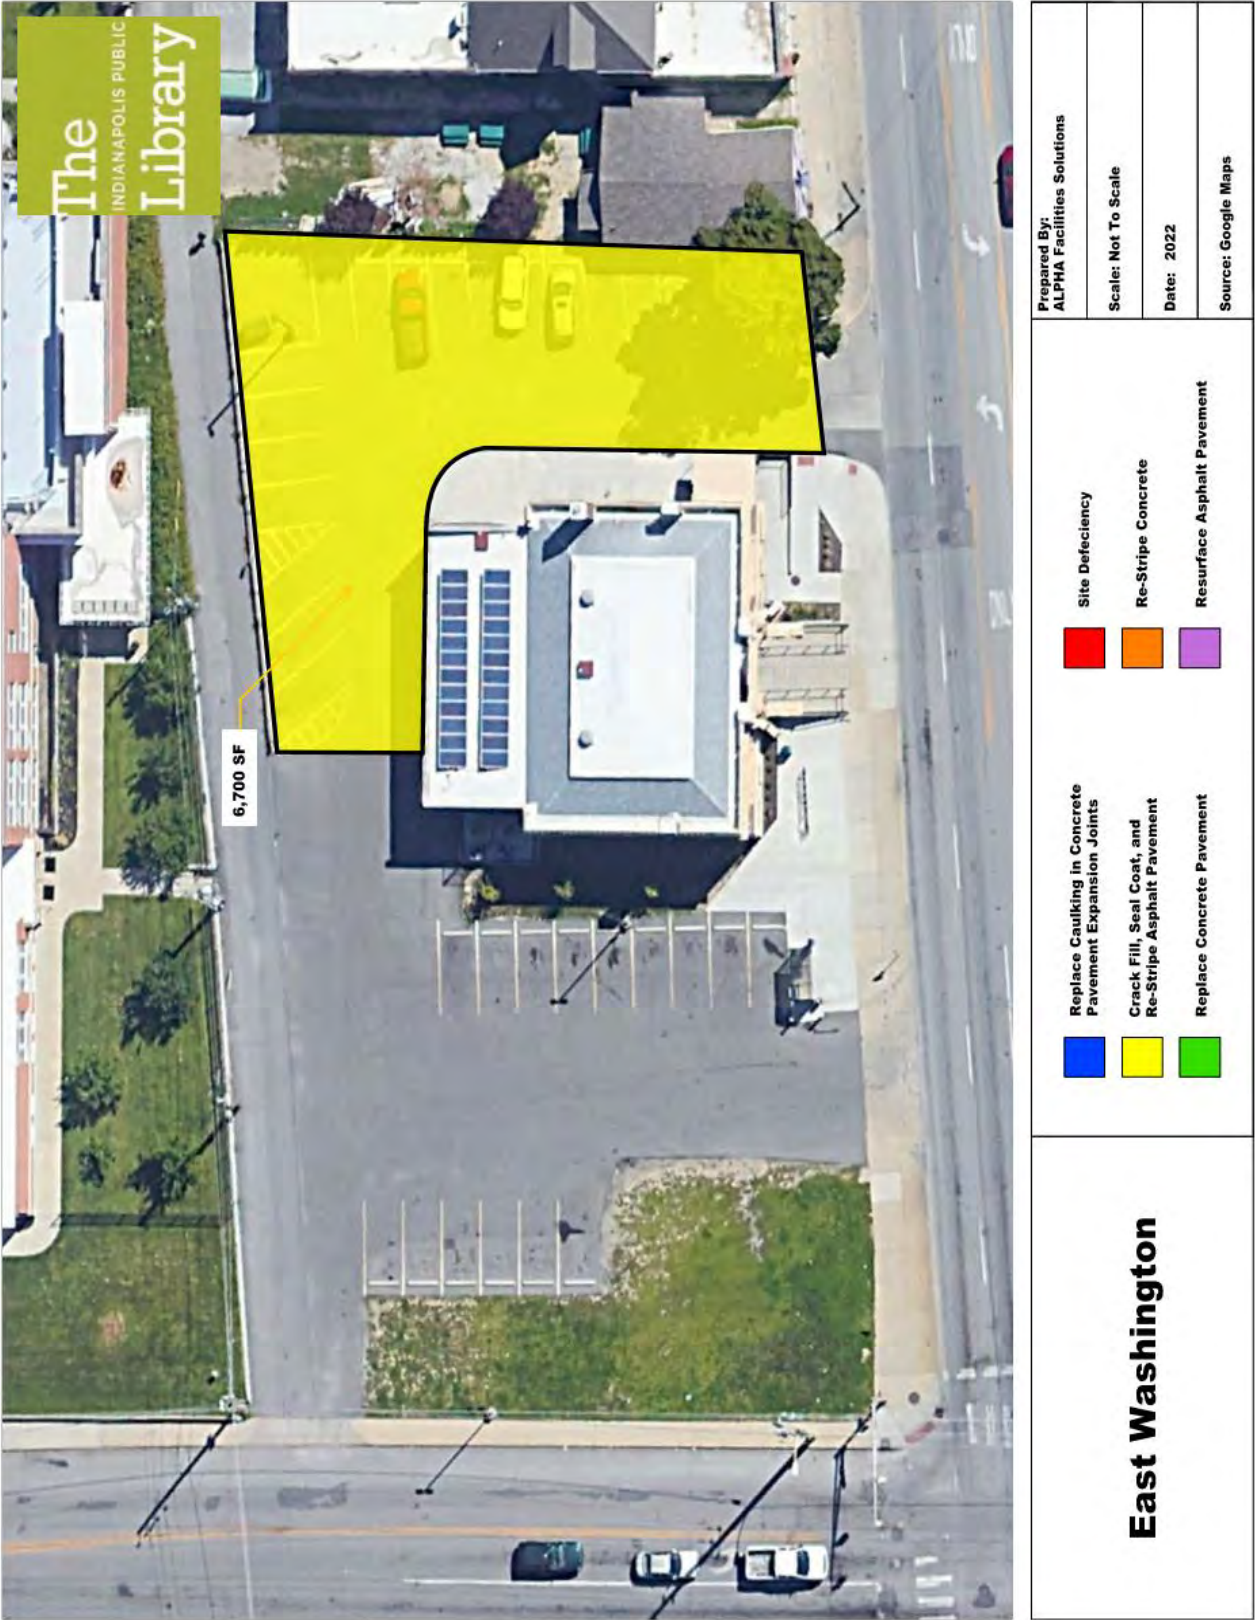
Figure 10. Site and Infrastructure Deficiencies Markup: East Washington

- A portion of the asphalt pavements were generally in poor condition and are in need of crack filling, seal coating, and re-striping due to several instances of cracking being observed.

Asset Description	Corrective Action	Notes	Priority	Current Needs	Year
Vehicular Pavements	Crack Fill, Seal Coat, and Restripe Asphalt Pavements	6700 SF @ \$1.2 Per SF	Low	\$8,040	2022
			Total 2022 Needs	\$8,040

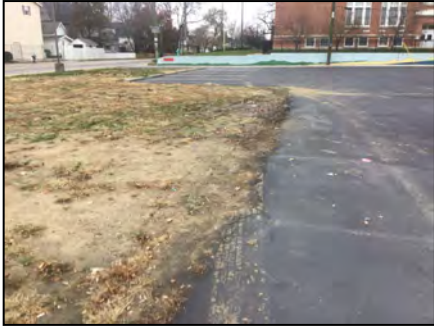
Site Infrastructure

A portion of the asphalt pavements were in poor condition and in need of resealing as longitudinal and transverse cracking were observed throughout the pavement.

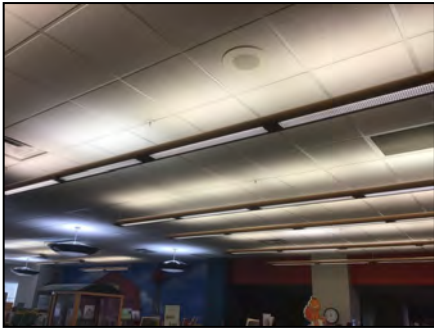
Electrical

The fluorescent and incandescent lighting was in good condition. The electrical branch wiring is within its recommended useful life. The service and distribution system was in good condition.

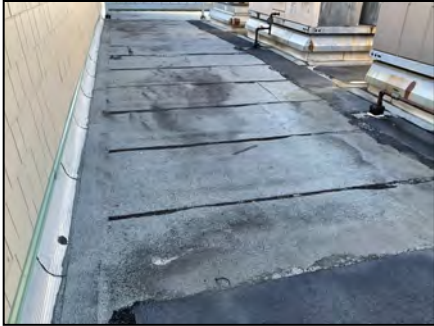
Exterior Enclosure

The metal and glazed doors were in good condition. The double-pane windows were in good condition. The brick veneer walls were in good condition. The modified bitumen and asphalt shingle roof covering are beyond their recommended useful lives.

Bottom of exterior hollow metal doors and frames are rusting. Some shingles have come loose. Steel framing on equipment screens is rusting.

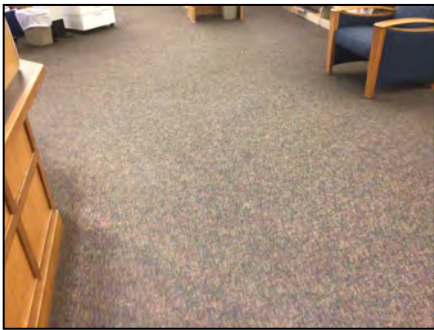
Interiors

The laminate wood, carpet and finished concrete floor finishes were in good condition. The tile, vinyl and painted wall finishes were in good condition. The painted, suspended acoustical tile and adhered acoustical tile ceiling finishes were in good condition.

Carpet is stained. Some stains on ceilings. Restroom floors are stained. Vinyl wall covering is peeling.

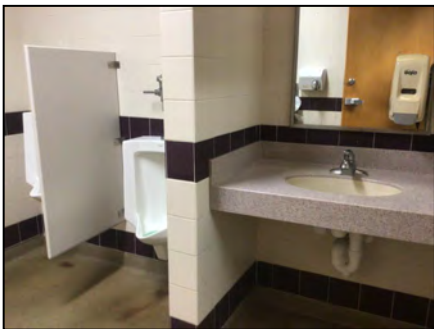
Plumbing

The porcelain and manual plumbing fixtures were in good condition. The domestic water distribution system is within its recommended useful life. The sanitary waste system is within its recommended useful life.

Sanitary system is in fair to poor condition. Staff requires lines to be jetted once per year. Water heaters are in good condition.

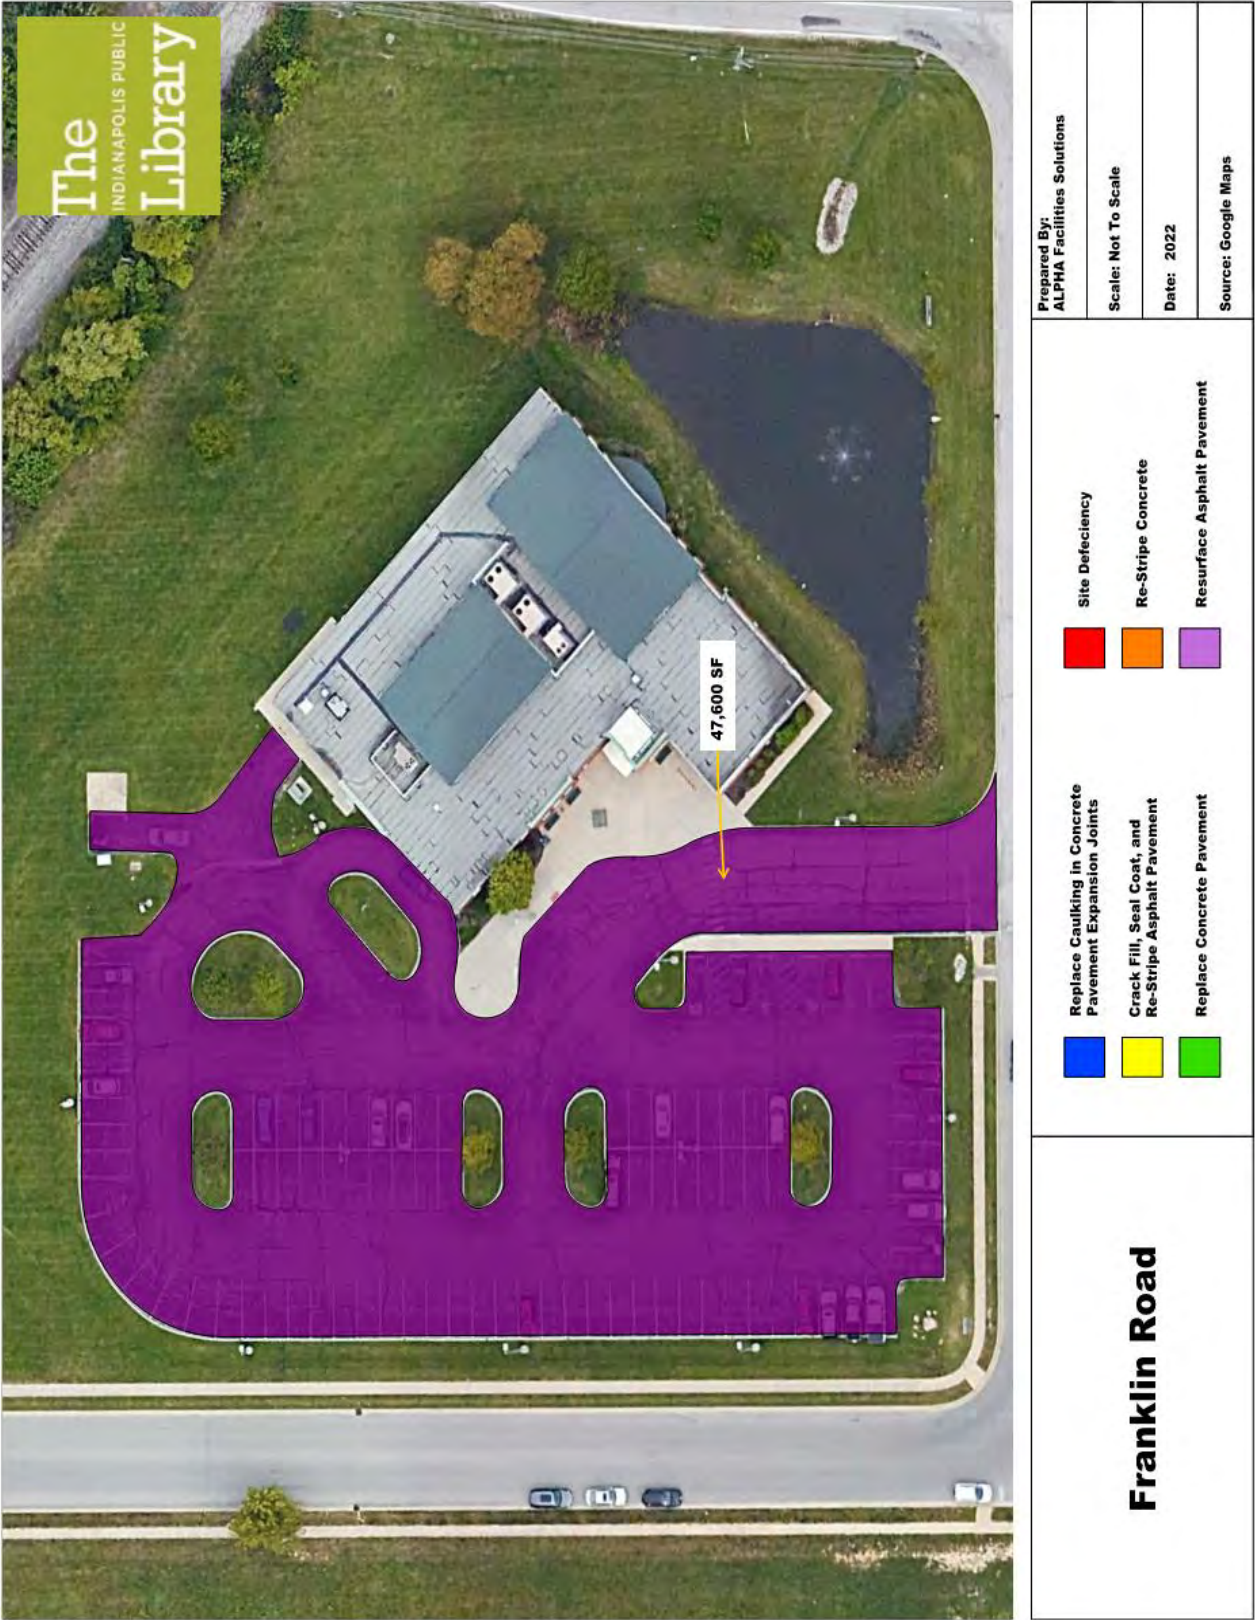
Figure 11. Site and Infrastructure Deficiencies Markup: Franklin Road

- The asphalt pavements were in poor condition and in need of resurfacing as longitudinal cracking, transverse cracking, and degradation were observed throughout the pavement.

Asset Description	Corrective Action	Notes	Priority	Current Needs	Year
Vehicular Pavements	Resurface Asphalt Pavements	47600 SF @ \$3.5 Per SF	Low	\$166,600	2022
			Total 2022 Needs	\$166,600

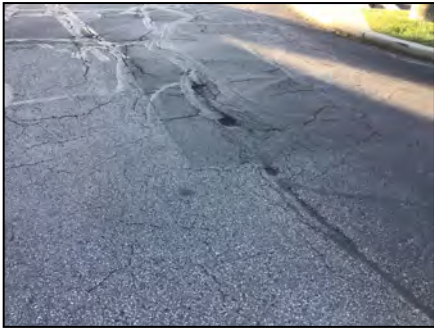
Site Infrastructure

The asphalt pavements were in poor condition and in need of resurfacing as longitudinal cracking, transverse cracking, and degradation were observed throughout the pavement.

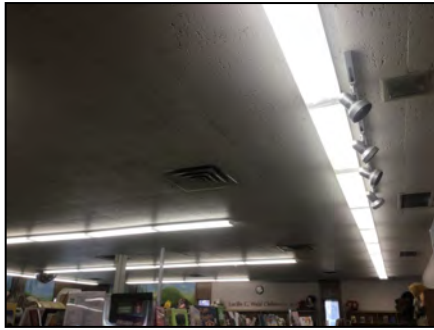
Electrical

The fluorescent lighting was in good condition. The electrical branch wiring is within its recommended useful life. The service and distribution system was in good condition. The emergency and exit lighting is within its recommended useful life.

Some of the electrical distribution is original and should be replaced.

There is no fire alarm system.

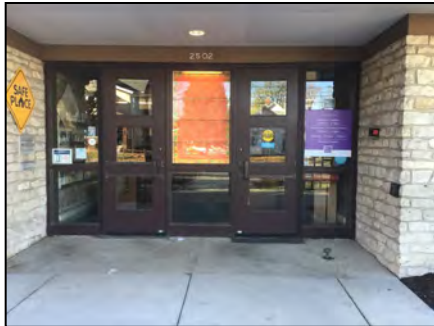
Exterior Enclosure

The metal and glazed doors were in good condition. The double-pane windows were in good condition. The brick veneer walls were in good condition. The asphalt shingle roof covering was within its recommended useful life.

Rust is forming at the base of exterior steel doors. Soffit trim is coming loose. Exposed steel structure is starting to rust. Sealant is deteriorated. Mechanical room exterior door has spray foam at the bottom and tape around the perimeter.

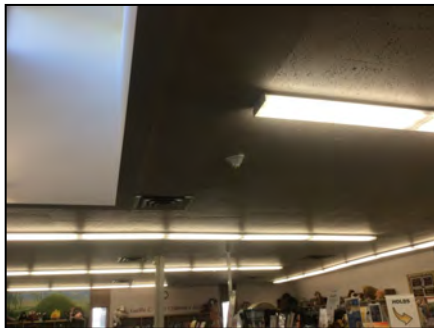
Interiors

The carpet and finished concrete floor finishes were in good condition. The vinyl and painted wall finishes were in good condition. The suspended acoustical tile and adhered acoustical tile ceiling finishes were in good condition.

Walk off mat is worn, carpet has stains. Restroom floors are stained. The vestibule is small and traps people who can't make it through both doors before the automatic door closes.

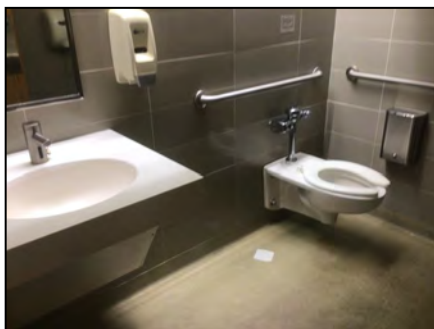
Plumbing

The porcelain and automated plumbing fixtures were in good condition. The domestic water distribution system is beyond its recommended useful life. The sanitary waste system is beyond its recommended useful life.

Water heater is in good condition.

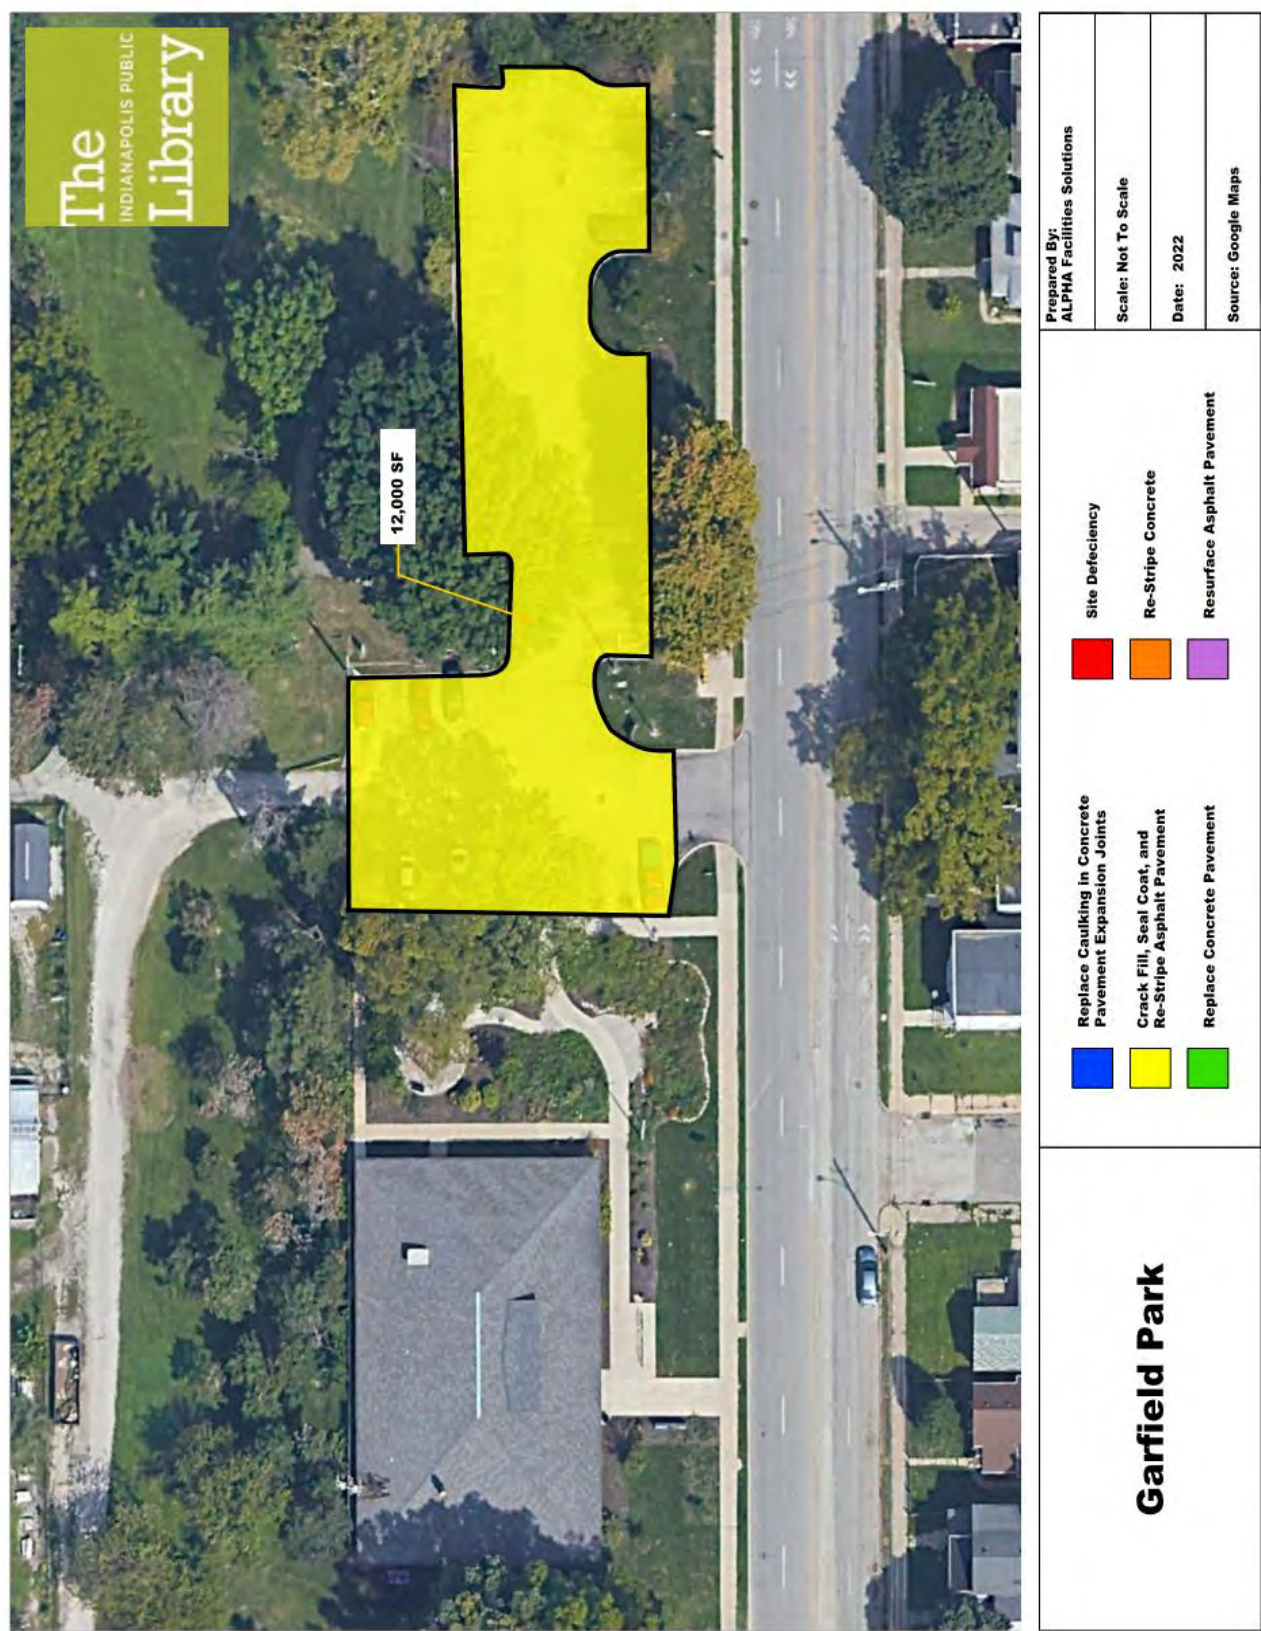
Figure 12. Site and Infrastructure Deficiencies Markup: Garfield Park

- The asphalt pavements were in poor condition and in need of resealing as longitudinal and transverse cracking were observed throughout the pavement.

Asset Description	Corrective Action	Notes	Priority	Current Needs	Year
Vehicular Pavements	Crack Fill, Seal Coat, and Restripe Asphalt Pavements	12000 SF @ \$1.2 Per SF	Low	\$14,400	2022
			Total 2022 Needs	\$14,400

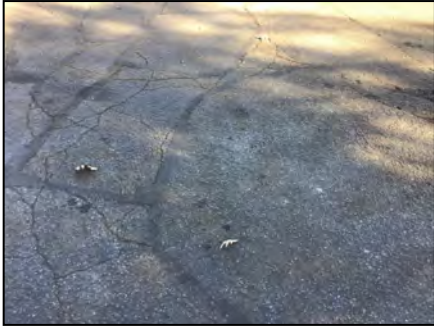
Site Infrastructure

The asphalt pavements were in poor condition and in need of resealing as longitudinal and transverse cracking were observed throughout the pavement.

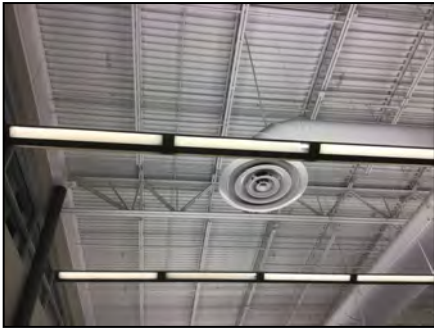
Electrical

The fluorescent lighting was in good condition. The electrical branch wiring is within its recommended useful life. The service and distribution system was in good condition. The emergency and exit lighting is within its recommended useful life.

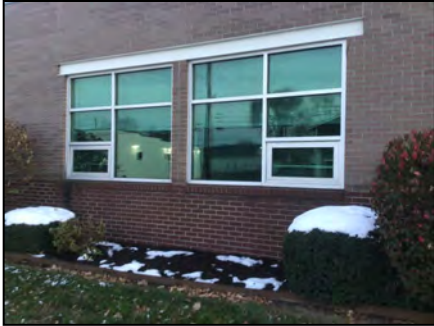
Exterior Enclosure

The metal and glazed doors were in good condition. The double-pane windows were in good condition. The brick veneer walls were in good condition. The modified bitumen roof covering was within its recommended useful life.

Brick veneer is cracking in several locations beneath the lintel. Roof is EPDM. Rust is starting to form at the base of steel doors and steel canopy structure.

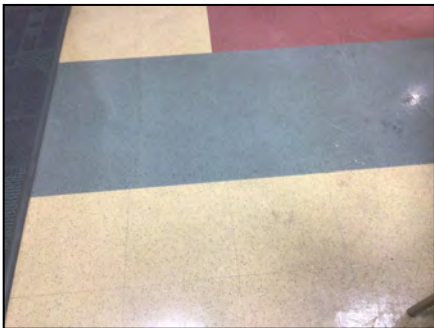
Interiors

The finished concrete, carpet and vinyl tile floor finishes were in good condition. The painted wall finishes were in good condition. The painted and suspended acoustical tile ceiling finishes were in good condition.

Carpet and tile has staining. Vinyl wall covering is beginning to peel. Stains noted on ceilings. Some cracking in drywall walls and ceilings.

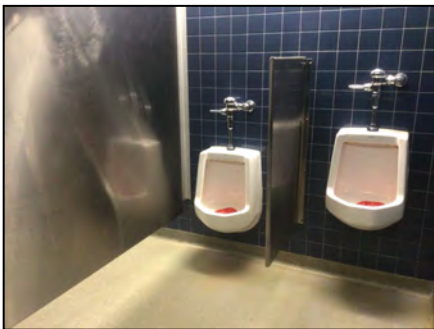
Plumbing

The porcelain and manual plumbing fixtures were in good condition. The domestic water distribution system is within its recommended useful life. The sanitary waste system is within its recommended useful life.

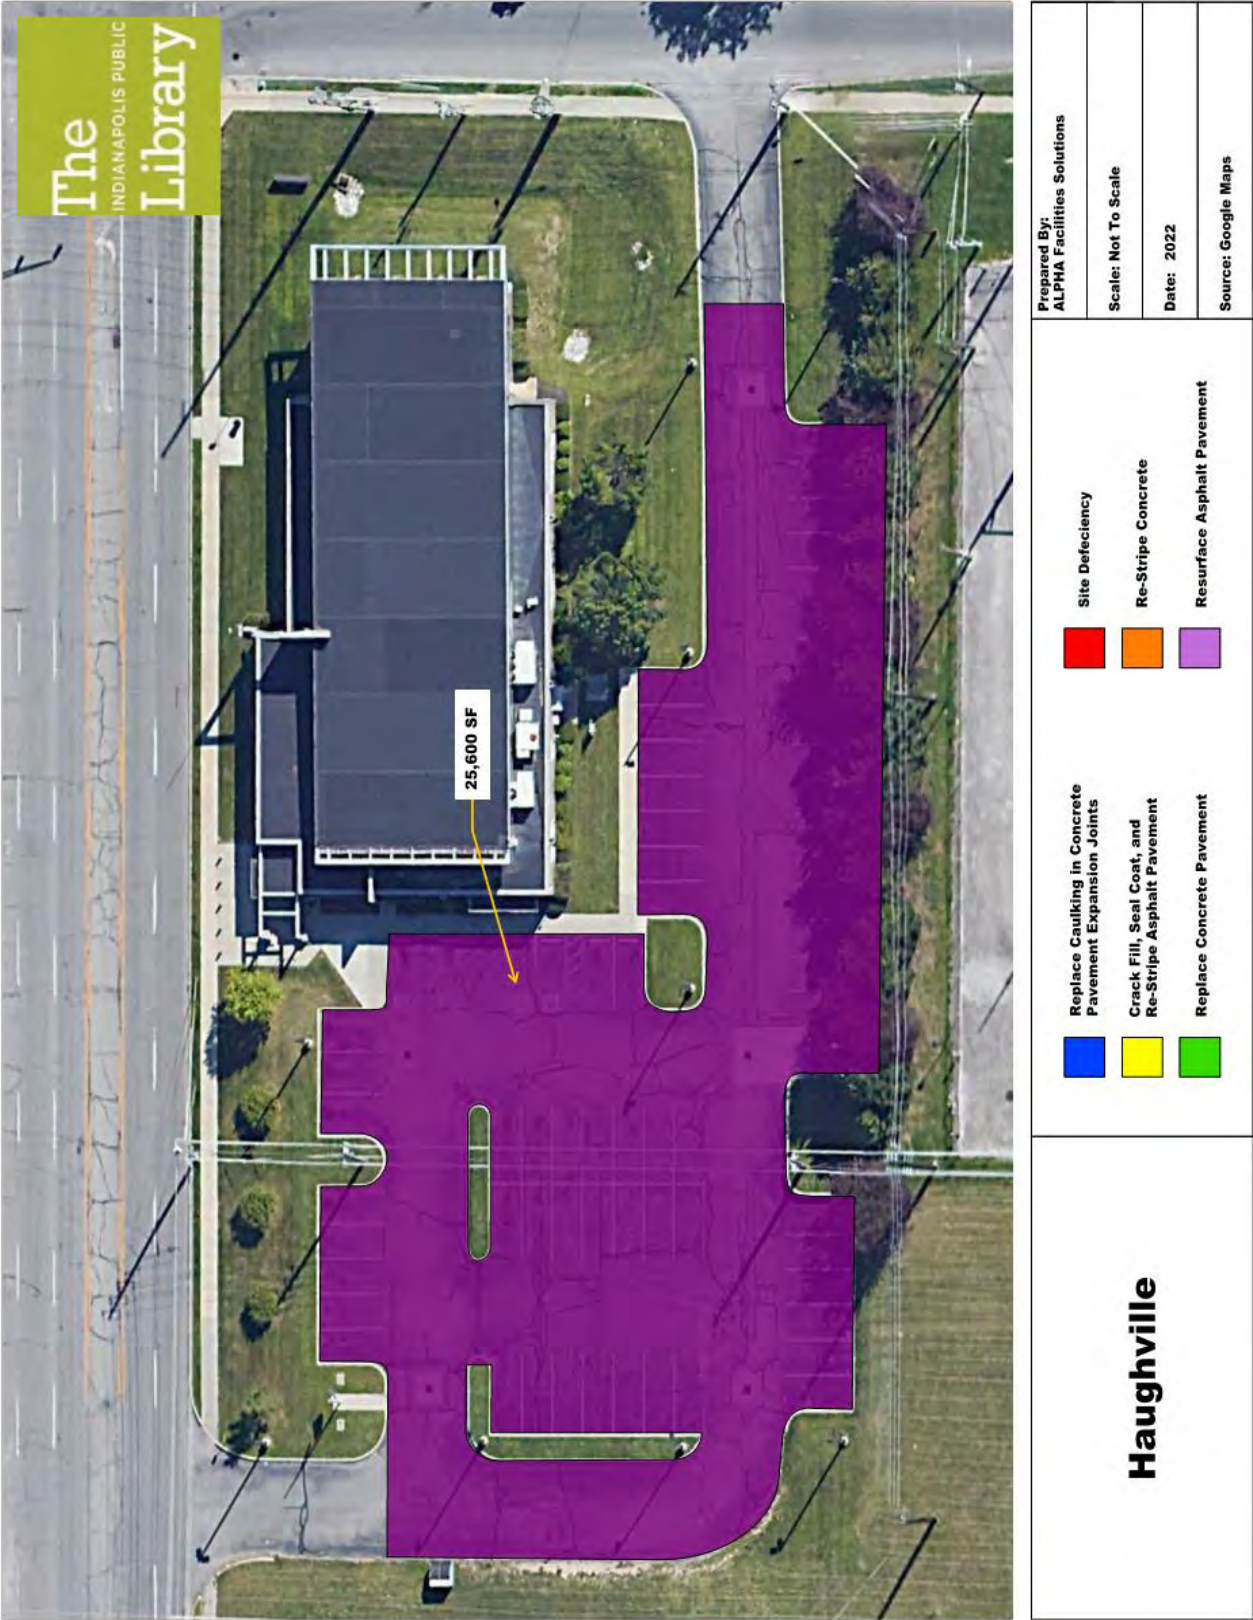
Figure 13. Site and Infrastructure Deficiencies Markup: Haughville

- The asphalt pavements were in poor condition and in need of resurfacing as longitudinal cracking, transverse cracking, and degradation were observed throughout the pavement.

Asset Description	Corrective Action	Notes	Priority	Current Needs	Year
Vehicular Pavements	Resurface Asphalt Pavements	25600 SF @ \$3.5 Per SF	Low	\$89,600	2022
			Total 2022 Needs	\$89,600

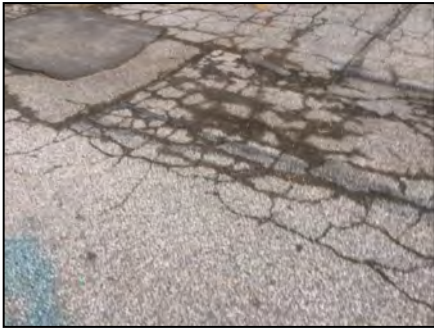
Site Infrastructure

The asphalt pavements were in poor condition and in need of resurfacing as longitudinal cracking, transverse cracking, and degradation were observed throughout the pavement.

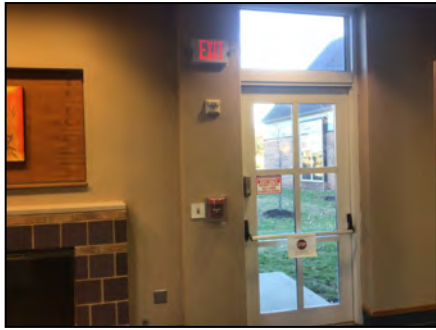
Electrical

The fluorescent lighting was in good condition. The electrical branch wiring is within its recommended useful life. The service and distribution system was in good condition. The emergency and exit lighting is beyond its recommended useful life.

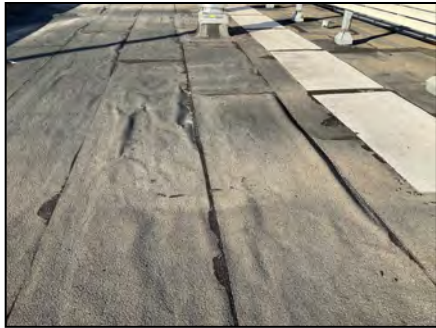
Exterior Enclosure

The metal and glazed doors were in good condition. The double-pane windows were in good condition. The brick veneer walls were in good condition. The modified bitumen and asphalt shingle roof covering were beyond their recommended useful lives.

Sealant is deteriorated. Brick on piers is spalling. Broken shingles were noted. The bottom of the EIFS was wet at the transition to brick.

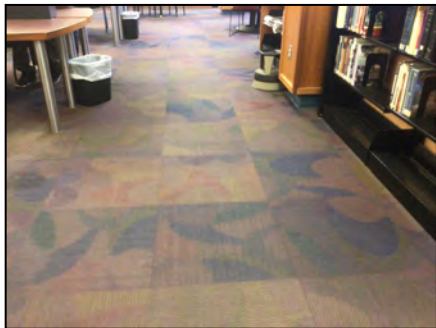
Interiors

The ceramic tile floor finishes were in good condition; however, the carpet floors were in fair condition due to observed deterioration. The tile, painted and vinyl wall finishes were in good condition. The suspended acoustical tile and painted ceiling finishes were in good condition.

Vinyl wall covering is peeling. Carpet is stained. Restroom counters are stained. Some water damage noted around windows and on ceilings. Drywall corners are cracked on vaulted ceilings.

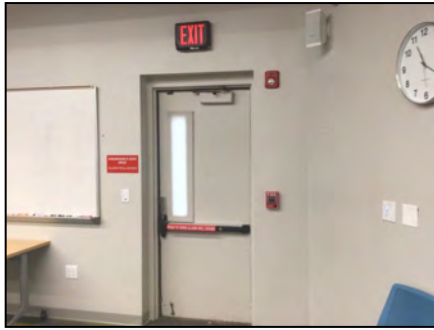
Electrical

The LED lighting was in good condition. The electrical branch wiring is within its recommended useful life. The service and distribution system was in good condition. The emergency and exit lighting is beyond its recommended useful life.

Original distribution and wiring installed in 1983 are at end of life.

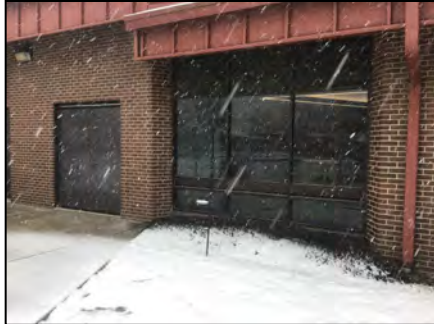
Exterior Enclosure

The metal and glazed doors were in good condition. The double-pane windows were in good condition. The brick veneer walls were in good condition. The asphalt shingle roof covering was within its recommended useful life.

Sealant is failing. Bottom of exterior hollow metal doors are rusting.

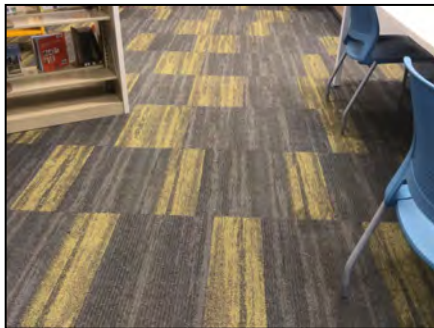
Interiors

The carpet and finished concrete floor finishes were in good condition. The painted wall finishes were in good condition. The suspended acoustical tile and wood ceiling finishes were in good condition.

Floors and partitions in restrooms are stained. Carpet is stained. Acoustical ceilings are stained.

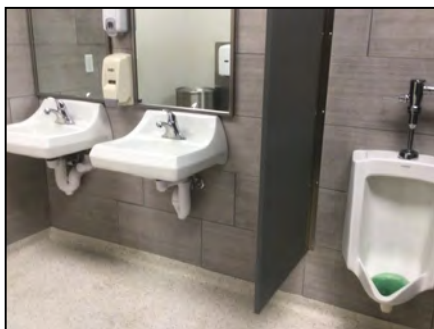
Plumbing

The porcelain and manual plumbing fixtures were in good condition. The domestic water distribution system is beyond its recommended useful life. The sanitary waste system is beyond its recommended useful life.

Sinks, lavatories and water closets are in good condition. Water heater is in good condition. Domestic distribution system and sanitary system appear to be in fair condition.
