Facilities Assessment

Facility Condition Assessment

Indianapolis Public Library

February 27, 2023

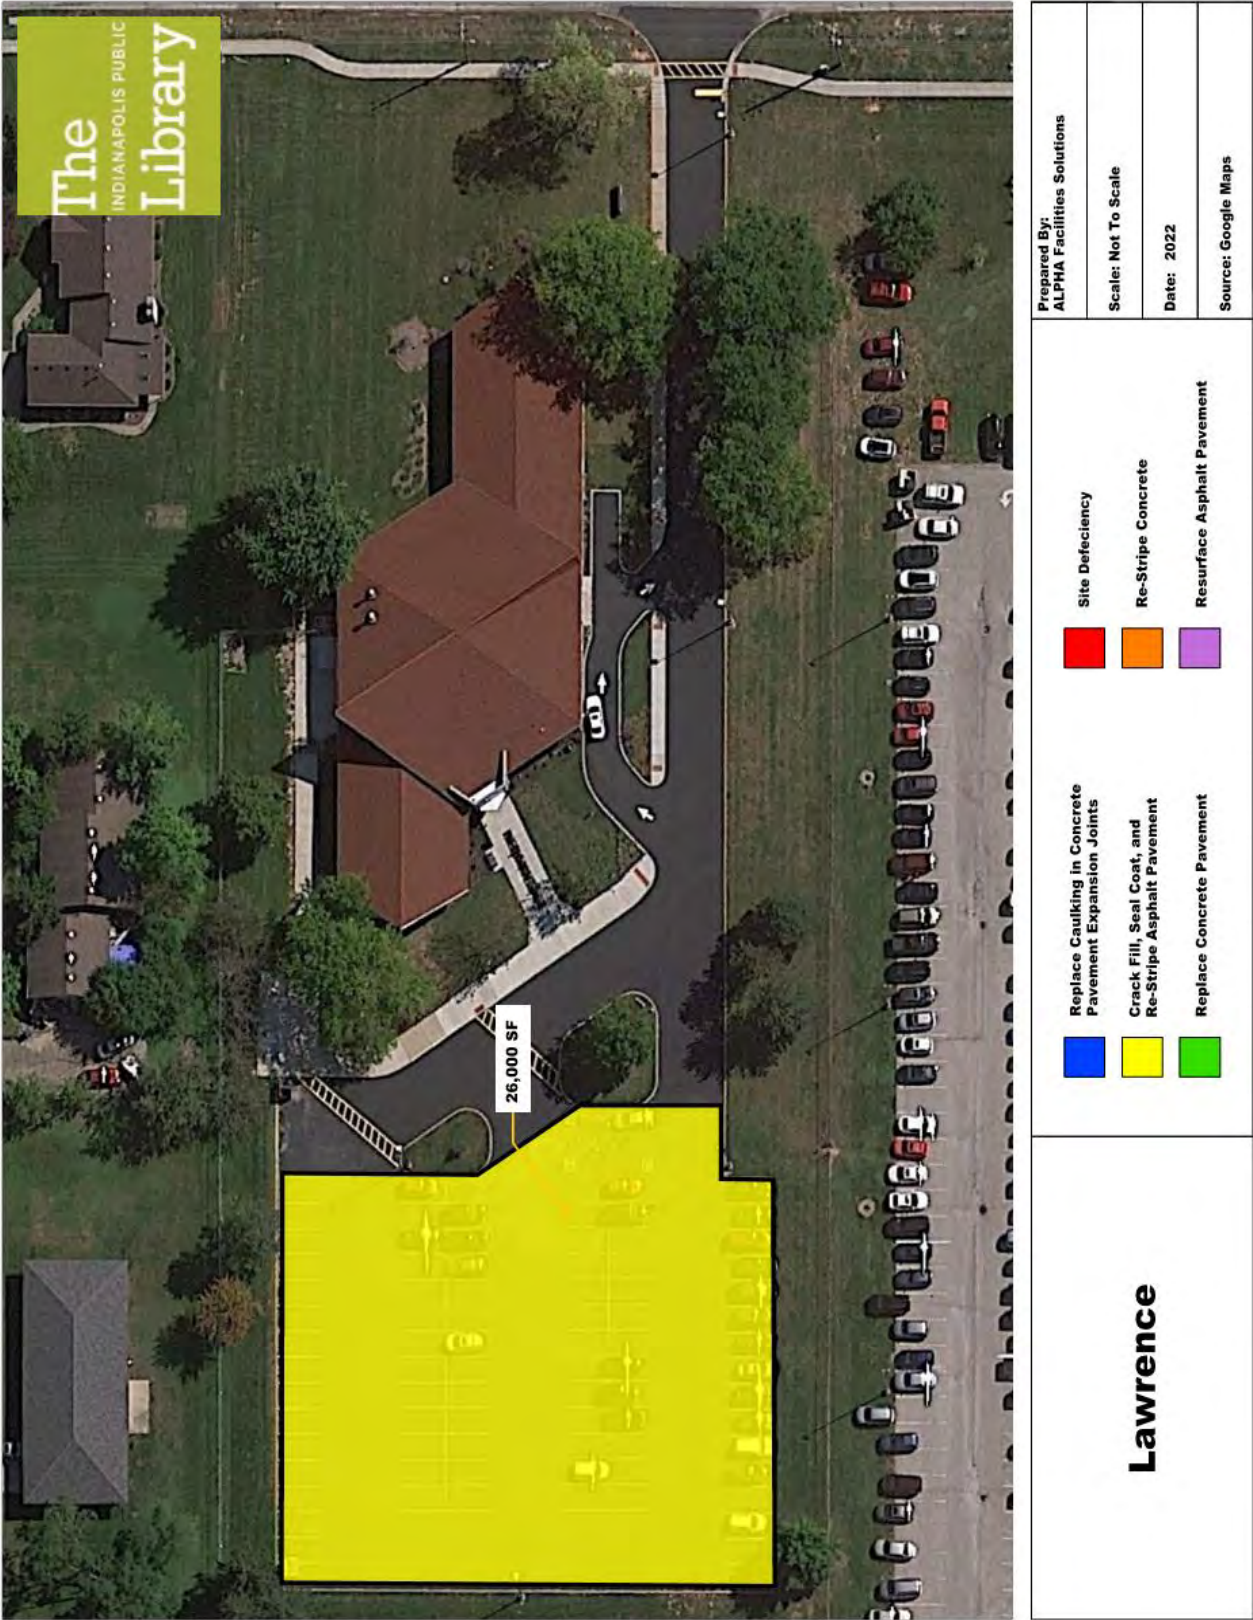
Figure 14. Site and Infrastructure Deficiencies Markup: Lawrence

- A portion of the asphalt pavements were generally in poor condition and are in need of crack filling, seal coating, and re-striping due to several instances of cracking being observed.

Asset Description	Corrective Action	Notes	Priority	Current Needs	Year
Vehicular Pavements	Crack Fill, Seal Coat, and Restripe Asphalt Pavements	26000 SF @ \$1.2 Per SF	Low	\$31,200	2022
			Total 2022 Needs	\$31,200

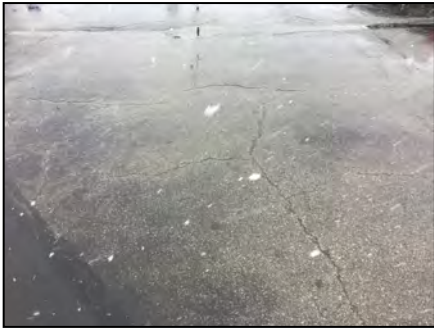
Site Infrastructure

A portion of the asphalt pavements were in poor condition and in need of resealing as longitudinal and transverse cracking were observed throughout the pavement.

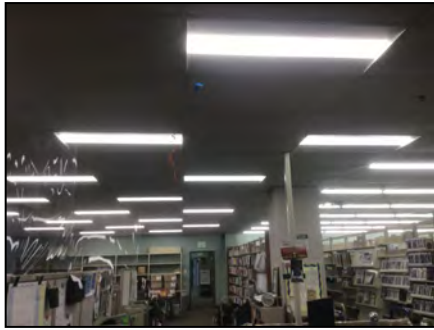
Electrical

The LED lighting was in good condition. The electrical branch wiring is beyond its recommended useful life. The service and distribution system was in good condition. The emergency and exit lighting is beyond its recommended useful life.

Branch circuit wiring is not beyond useful life.
Fire alarm system age needs to be verified. If 20+ years, replacement should be considered.
Emergency and exit lighting age needs to be determined, appears to be 5-10 years old.

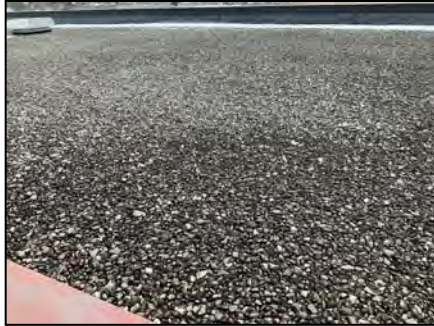
Exterior Enclosure

The glazed and metal doors were in good condition. The double-pane windows were in good condition. The brick veneer walls were in good condition. The built-up membrane roof covering was beyond its recommended useful life.

Ballasted EPDM roof needs replaced. The glazed arch has a leak. The exterior steel door at the garage is rusted.

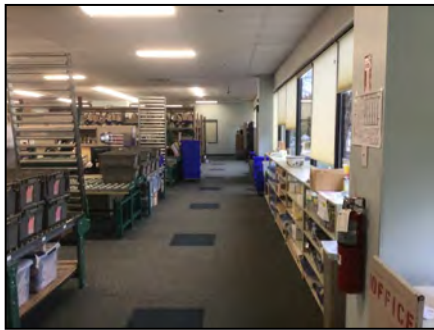
Interiors

The finished concrete, carpet and ceramic tile floor finishes were in good condition. The painted and vinyl wall finishes were in good condition. The suspended acoustical tile and painted ceiling finishes were in good condition.

The carpet has stains. The wall coverings are peeling and buckled on the first floor and in the lobby. Interior doors have wear on the finish. Sorting room walls are damaged from carts. Ceiling tile in the book sale area has stains.

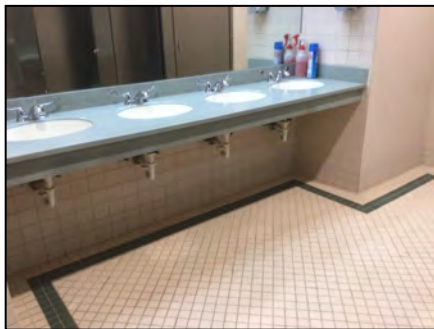
Plumbing

The porcelain and manual plumbing fixtures were in good condition. The domestic water distribution system is beyond its recommended useful life. The sanitary waste system is beyond its recommended useful life.

Fixtures are in good condition, water closets currently being replaced.

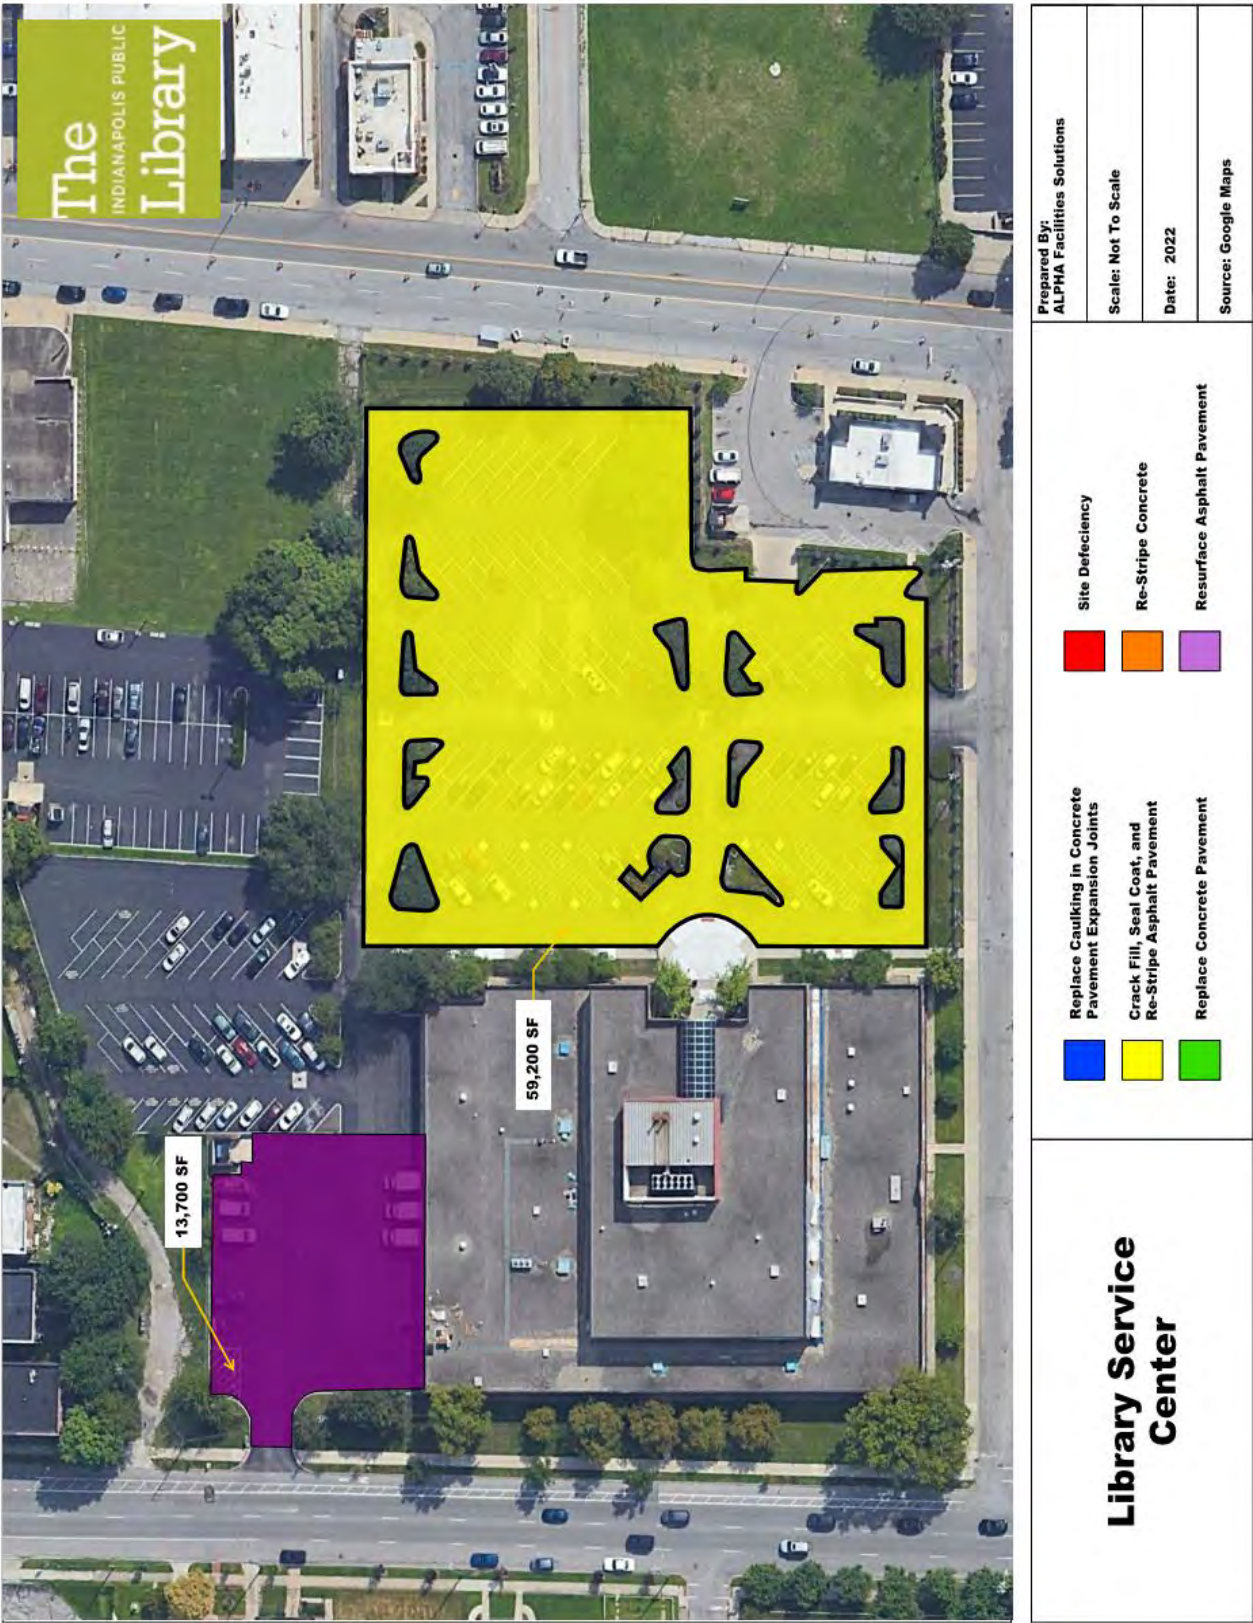
Figure 15. Site and Infrastructure Deficiencies Markup: Library Service Center

- A portion of the asphalt pavements were in poor condition and in need of resurfacing as longitudinal cracking, transverse cracking, and degradation were observed throughout the pavement.
- A portion of the asphalt pavements were generally in poor condition and are in need of crack filling, seal coating, and re-striping due to several instances of cracking being observed.

Asset Description	Corrective Action	Notes	Priority	Current Needs	Year
Vehicular Pavements	Crack Fill, Seal Coat, and Restripe Asphalt Pavements	59200 SF @ \$1.2 Per SF	Low	\$71,040	2022
Vehicular Pavements	Resurface Asphalt Pavements	13700 SF @ \$3.5 Per SF	Low	\$47,950	2022
			Total 2022 Needs	\$118,990

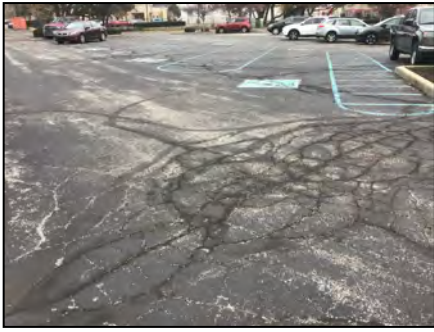
Site Infrastructure

A portion of the asphalt pavements were in poor condition and in need of resealing as longitudinal and transverse cracking were observed throughout the pavement.

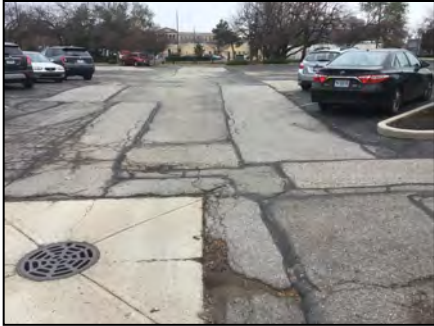
Site Infrastructure

A portion of the asphalt pavements were in poor condition and in need of resurfacing as longitudinal cracking, transverse cracking, and degradation were observed throughout the pavement.

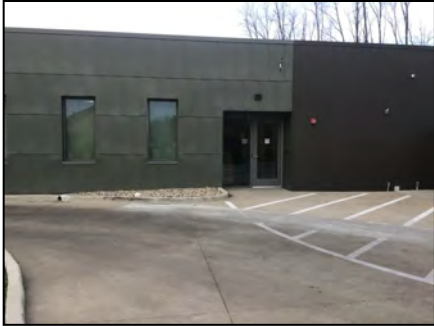
Exterior Enclosure

The glazed and metal doors were in good condition. The double-pane windows were in good condition. The brick veneer and metal siding walls were in good condition. The modified bitumen roof covering was within its recommended useful life.

The roof access ladder is beginning to rust. There was spray foam at the base of the exterior mechanical room door. The main entry columns are beginning to rust around the base. The wood is deteriorating at the entry canopy. The interior pane of a window in the community room is broken.

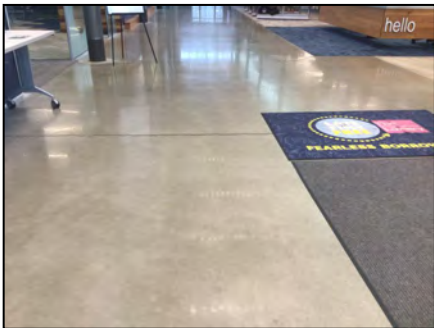
Interiors

The finished concrete, carpet and resilient floor finishes were in good condition. The painted and vinyl wall finishes were in good condition. The suspended acoustical tile and wood ceiling finishes were in good condition.

Wall covering is peeling from columns. The drywall is cracked in the men's restroom. Grout is stained under the hand dryers. Sealant is cracked at lavatories. Walls are damaged from furniture. Carpet in Admin area is stained.

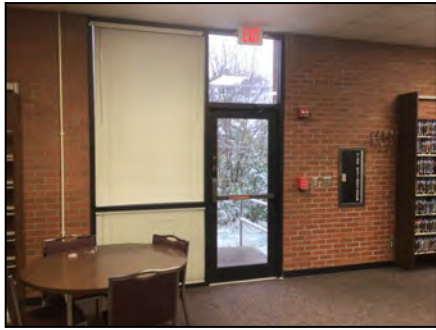
Electrical

The LED lighting was in good condition. The electrical branch wiring is beyond its recommended useful life. The service and distribution system was in good condition. The emergency and exit lighting is beyond its recommended useful life.

The electrical equipment is beyond life, installed in 1971. Emergency and exit lighting are not beyond life if part of LED upgrades.

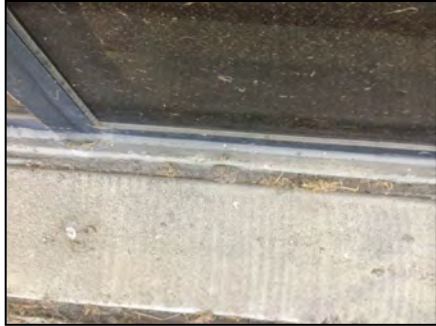
Exterior Enclosure

The metal and glazed doors were in good condition. The double-pane windows were in fair condition due to observed deteriorated window seals. The brick veneer walls were in good condition. The ~~modified bitumen~~ EPDM roof covering was beyond its recommended useful life.

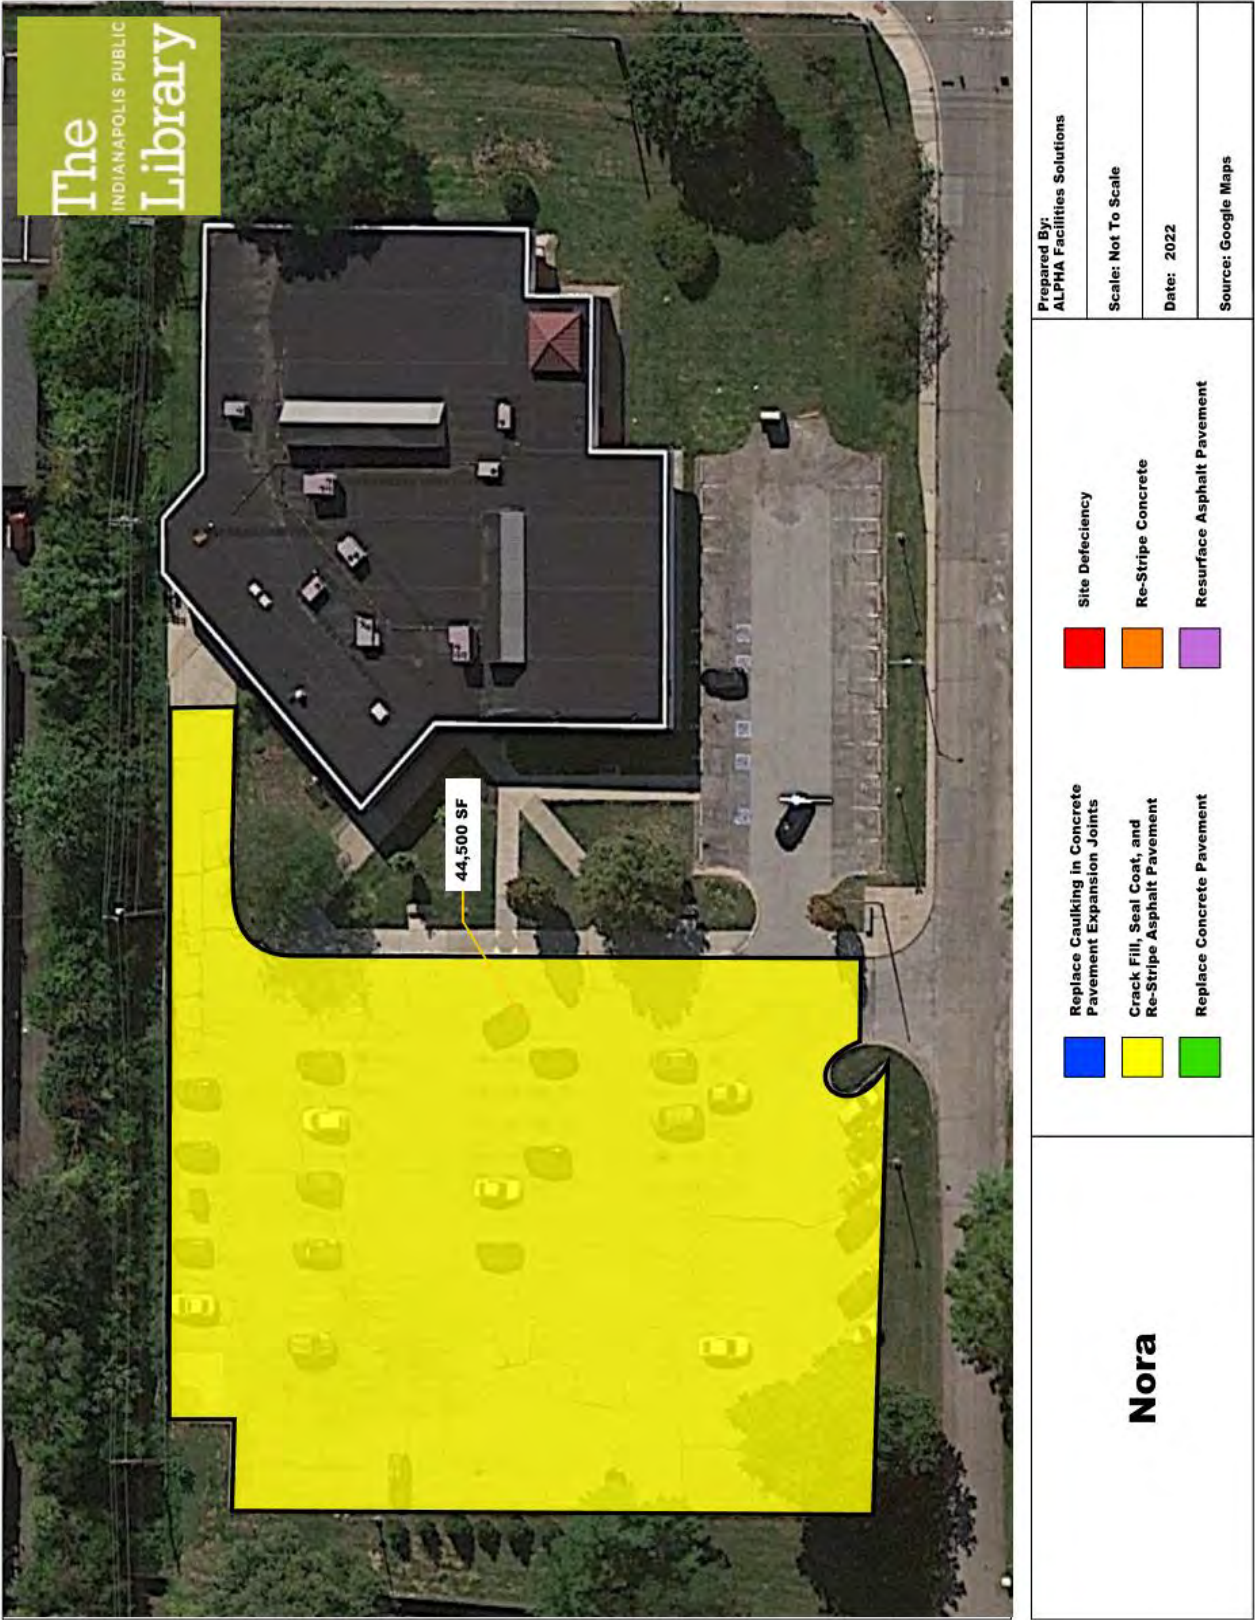
Figure 16. Site and Infrastructure Deficiencies Markup: Nora

- The asphalt pavements were in poor condition and in need of resealing as longitudinal and transverse cracking were observed throughout the pavement.

Asset Description	Corrective Action	Notes	Priority	Current Needs	Year
Vehicular Pavements	Crack Fill, Seal Coat, and Restripe Asphalt Pavements	44500 SF @ \$1.2 Per SF	Low	\$53,400	2022
			Total 2022 Needs	\$53,400

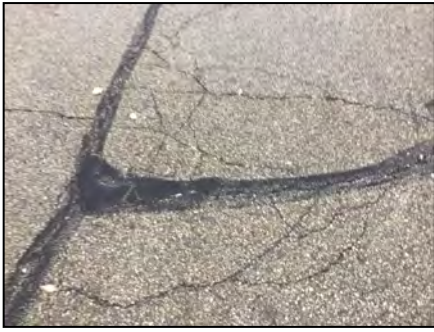
Site Infrastructure

The asphalt pavements were in poor condition and in need of resealing as longitudinal and transverse cracking were observed throughout the pavement.

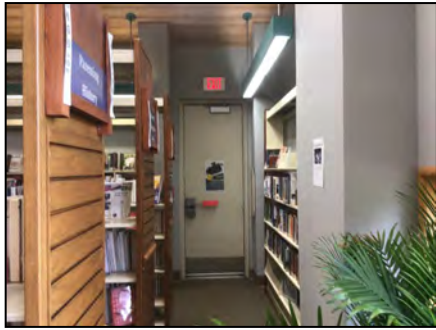
Electrical

The fluorescent lighting was in good condition. The electrical branch wiring is beyond its recommended useful life. The service and distribution system was in good condition. The emergency and exit lighting is beyond its recommended useful life.

There are LED retrofits lamps installed.
Branch circuit wiring is approaching end of life.

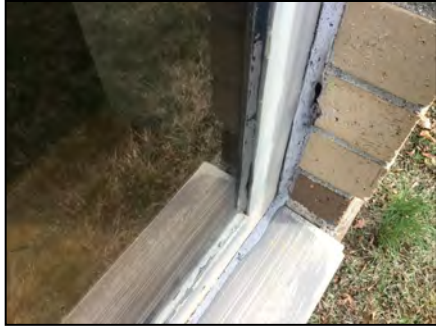
Exterior Enclosure

The metal and glazed doors were in good condition. The double-pane windows were in poor condition due to observed deteriorated window seals. The brick veneer walls were in poor condition due to observed damaged finishes. The asphalt shingle roof covering was beyond its recommended useful life.

Rust is forming at the base of exterior steel doors and frames. Splash blocks were installed backwards.

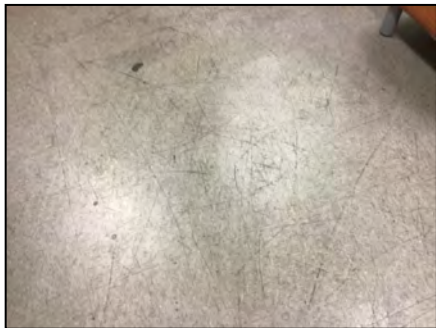
Interiors

The carpet and ceramic tile floor finishes were in fair condition due to observed stains, and the vinyl tile floors were in poor condition due to observed damage. The vinyl and painted wall finishes were in good condition; however, the tile walls were in fair condition due to observed stains. The wood and suspended acoustical tile ceiling finishes were in good condition.

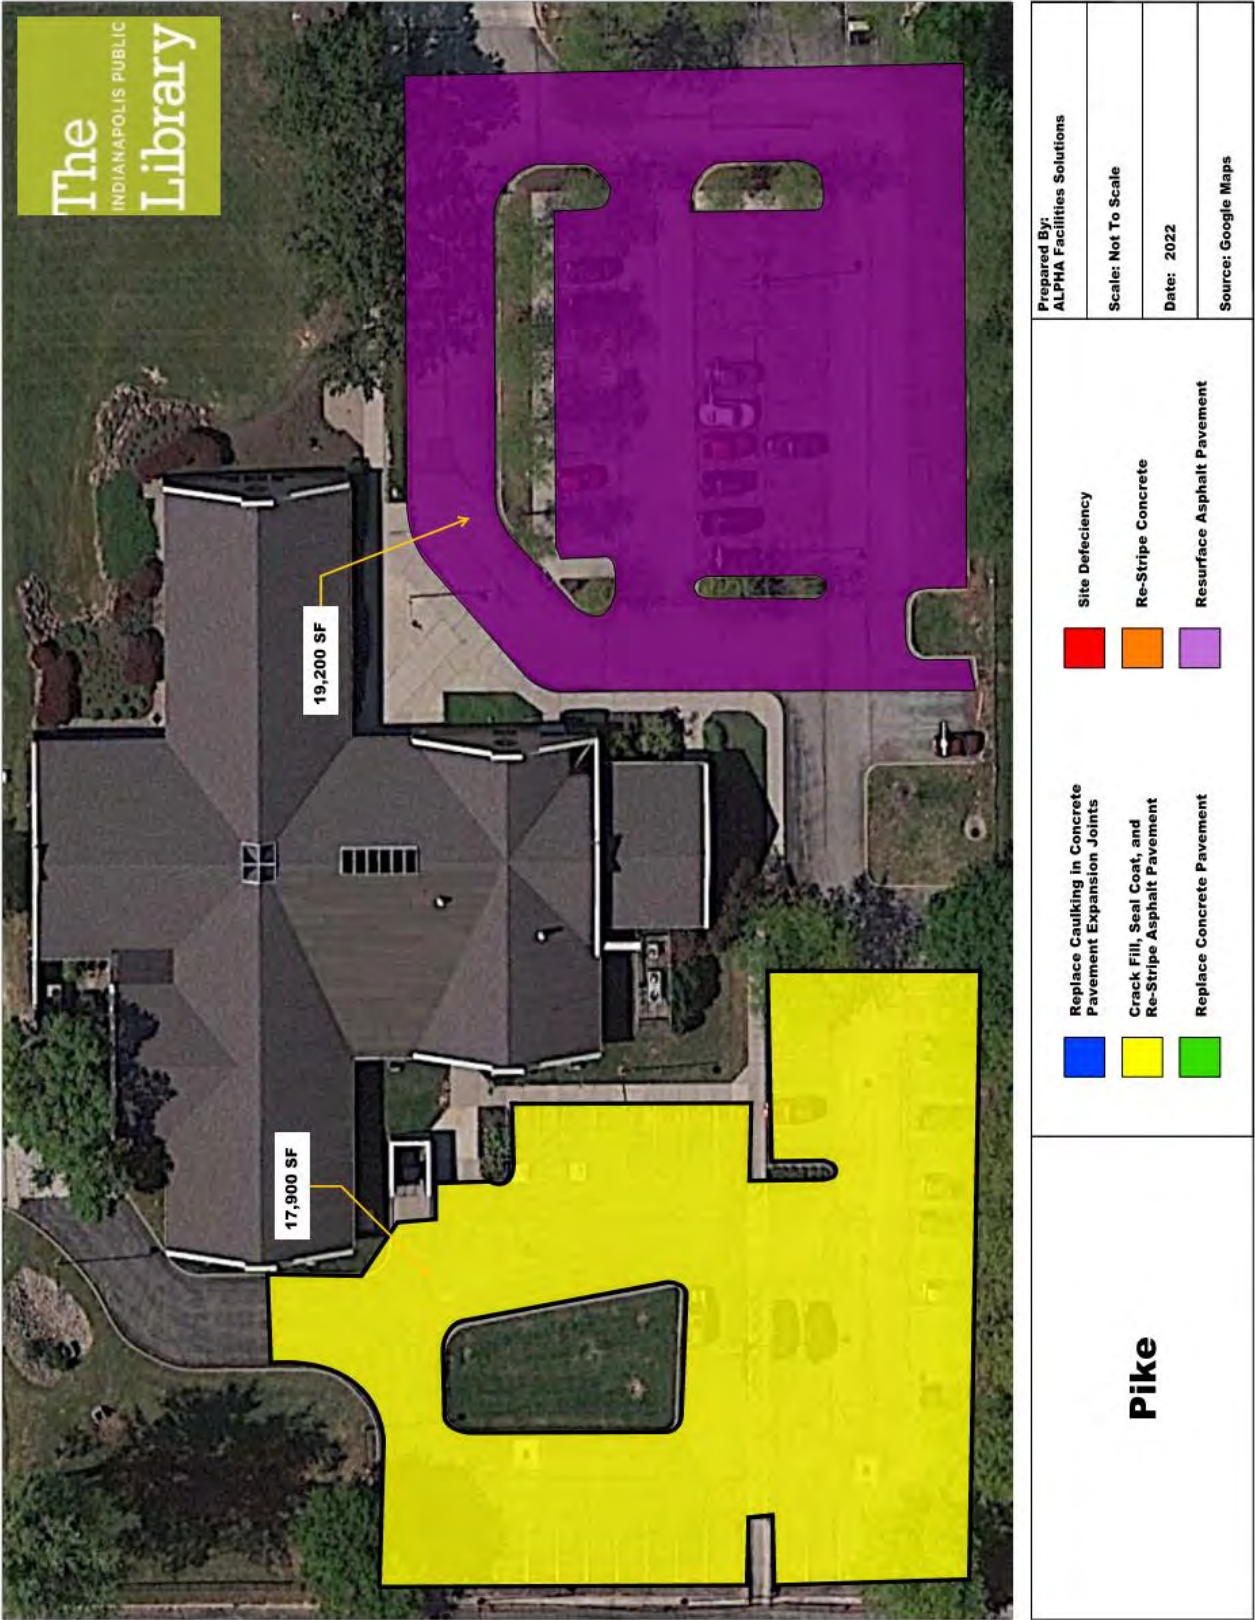
Figure 17. Site and Infrastructure Deficiencies Markup: Pike

Asset Description	Corrective Action	Notes	Priority	Current Needs	Year
Vehicular Pavements	Crack Fill, Seal Coat, and Restripe Asphalt Pavements	17900 SF @ \$1.2 Per SF	Low	\$21,480	2022
Vehicular Pavements	Resurface Asphalt Pavements	19200 SF @ \$3.5 Per SF	Low	\$67,200	2022
			Total 2022 Needs	\$88,680

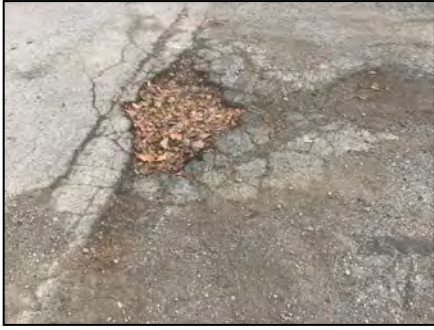
Site Infrastructure

A portion of the asphalt pavements were in poor condition and in need of resurfacing as longitudinal cracking, transverse cracking, and degradation were observed throughout the pavement.

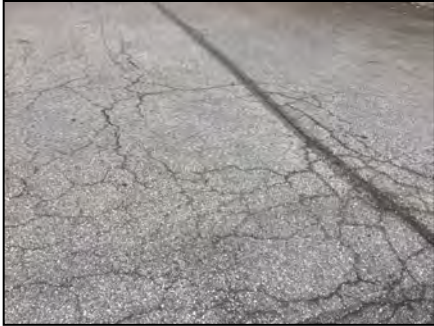
Site Infrastructure

A portion of the asphalt pavements were in poor condition and in need of resealing as longitudinal and transverse cracking were observed throughout the pavement.

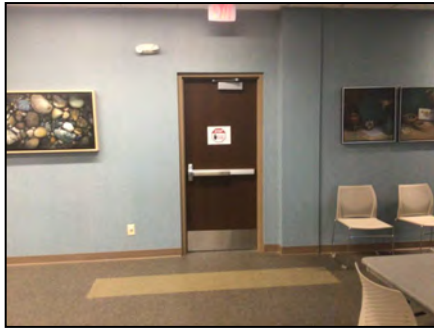
Electrical

The LED lighting was in good condition. The electrical branch wiring is within its recommended useful life. The service and distribution system was in good condition. The emergency and exit lighting is beyond its recommended useful life.

Original electrical distribution is beyond end of life. Emergency and exit lighting appear to be recent. Fire alarm system is beyond end of life.

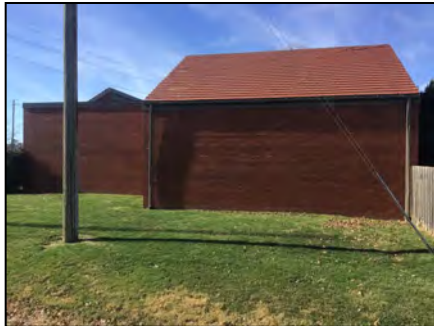
Exterior Enclosure

The metal and glazed doors were in good condition. The double-pane windows were in good condition. The brick veneer walls were in good condition. The modified bitumen roof covering was within its recommended useful life; however, the slate shingle roof was beyond its recommended useful life.

Damage to the screen wall at the main entrance. Loose roof tiles. Sealant is deteriorated. Rust at base of exterior steel doors and frames.

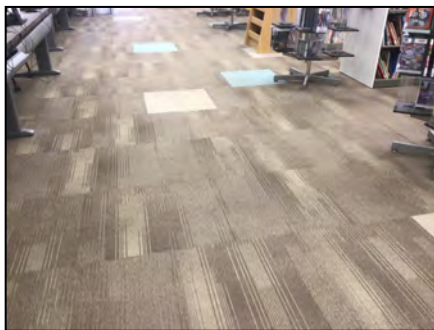
Interiors

The carpet and ceramic tile floor finishes were in good condition. The vinyl and painted wall finishes were in good condition. The suspended acoustical tile and wood ceiling finishes were in good condition.

Stains on carpet and grout. Stains on toilet partition. No sealant on backsplash in restroom.

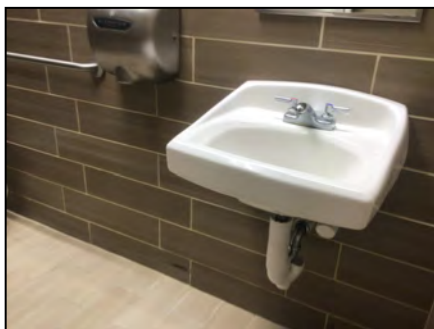
Plumbing

The porcelain and manual plumbing fixtures were in good condition. The domestic water distribution system is beyond its recommended useful life. The sanitary waste system is beyond its recommended useful life.

One toilet fixture is in poor condition. Sanitary system drains slowly per staff onsite. Water heaters are in fair condition.

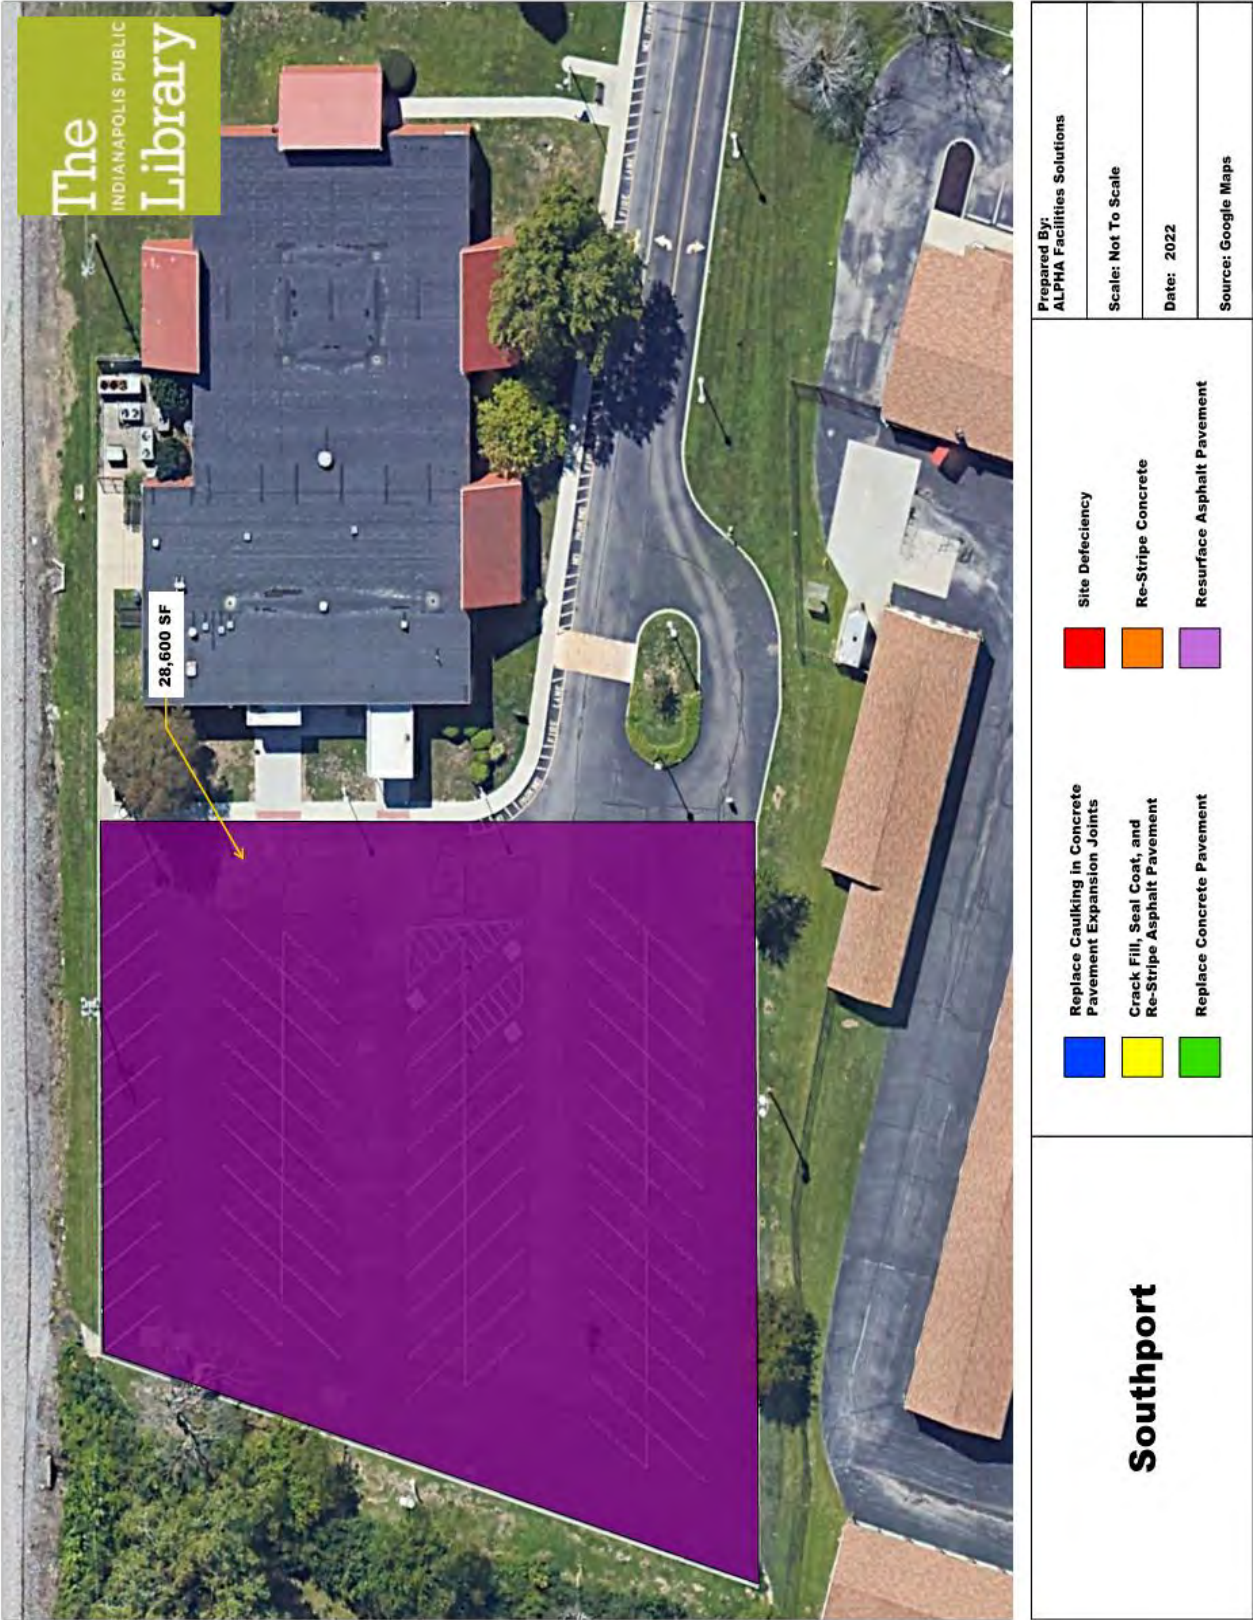
Figure 18. Site and Infrastructure Deficiencies Markup: Southport

Asset Description	Corrective Action	Notes	Priority	Current Needs	Year
Vehicular Pavements	Resurface Asphalt Pavements	28600 SF @ \$3.5 Per SF	Low	\$100,100	2022
			Total 2022 Needs	\$100,100

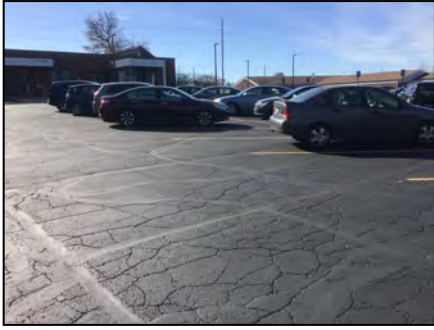
Site Infrastructure

The asphalt pavements were in poor condition and in need of resurfacing as longitudinal cracking, transverse cracking, and degradation were observed throughout the pavement.

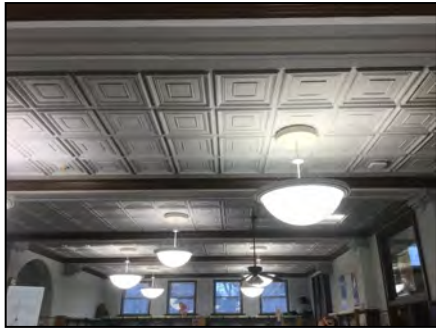
Electrical

The LED lighting was in good condition. The electrical branch wiring is beyond its recommended useful life. The service and distribution system was in good condition. The emergency and exit lighting is within its recommended useful life.

The distribution equipment is approaching end of life, installed in 1986.

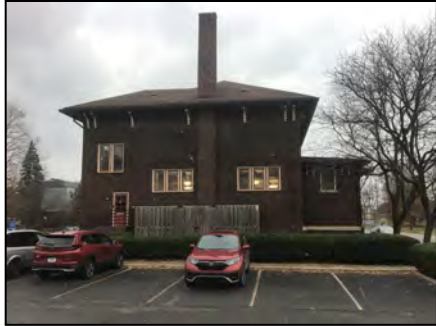
Exterior Enclosure

The wooden doors were in good condition. The double-pane windows were in good condition. The brick veneer walls were in good condition. The asphalt shingle roof covering was beyond its recommended useful life.

Some tuckpointing is needed on the lower portion of the brick and at the joints in the stone at the main entry. The staff entry door is delaminating. There is some damage to the staff entry steps. Paint is peeling on the base of the wood elevator entry.

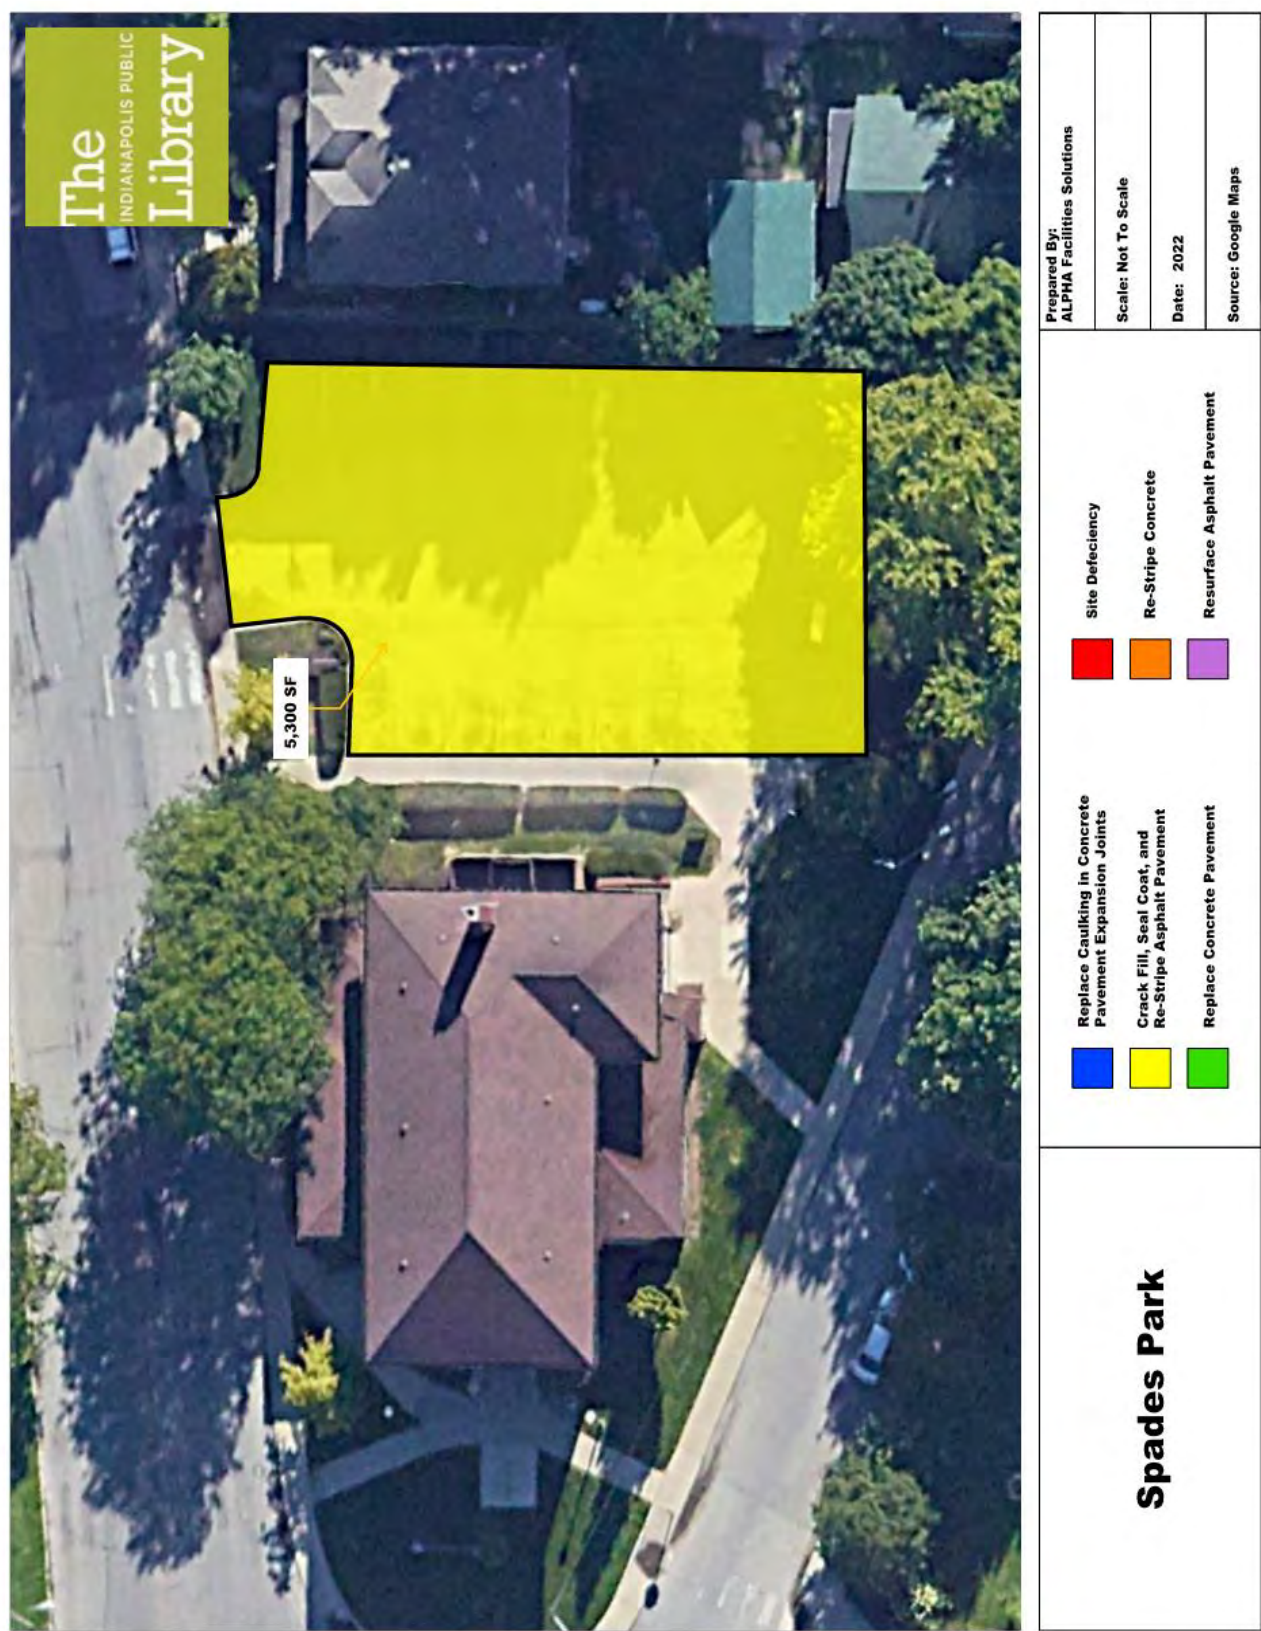
Figure 19. Site and Infrastructure Deficiencies Markup: Spades Park

Asset Description	Corrective Action	Notes	Priority	Current Needs	Year
Vehicular Pavements	Crack Fill, Seal Coat, and Restripe Asphalt Pavements	5300 SF @ \$1.2 Per SF	Low	\$6,360	2022
			Total 2022 Needs	\$6,360

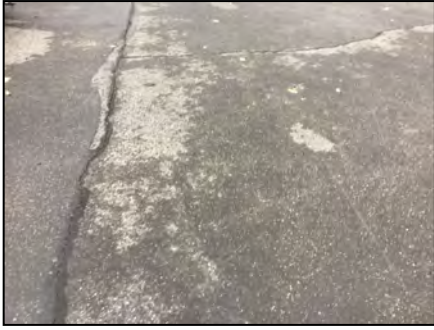
Site Infrastructure

The asphalt pavements were in poor condition and in need of resealing as longitudinal and transverse cracking were observed throughout the pavement.

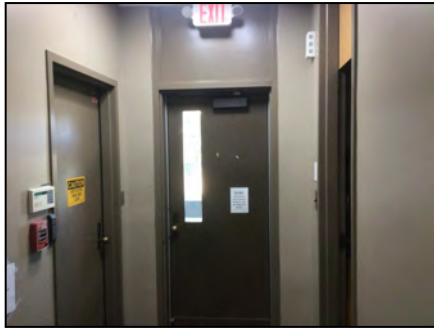
Electrical

The LED lighting was in good condition. The electrical branch wiring is within its recommended useful life. The service and distribution system was in good condition. The emergency and exit lighting is beyond its recommended useful life.

The original distribution, 1974, as at end of useful life.

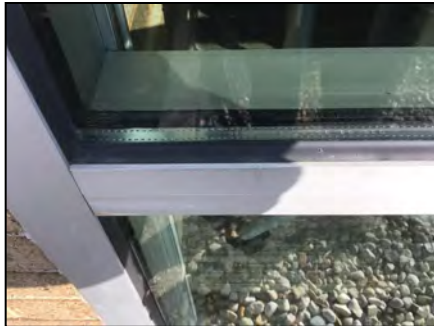
Exterior Enclosure

The metal and glazed doors were in good condition. The double-pane windows were in poor condition due to observed deteriorated window seals. The brick veneer walls were in good condition. The ~~modified bitumen~~ roof covering was within its recommended useful life. EPDM

Bottom of fascia is rusted. Sealant is deteriorating. Structural steel is starting to rust at entry. Bottom of exterior hollow metal doors and frames are rusting.

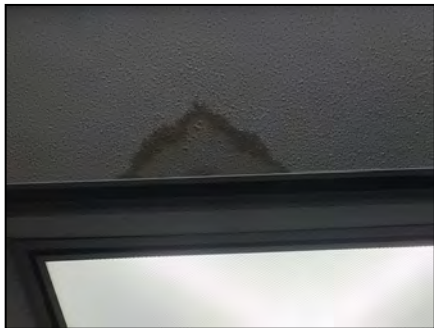
Interiors

The vinyl tile, carpet and laminate wood floor finishes were in good condition. The vinyl and painted wall finishes were in good condition. The suspended acoustical tile ceiling finishes were in poor condition due to observed stains.

Carpet and grout are stained

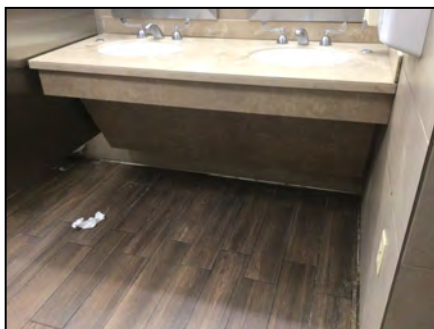
Plumbing

The porcelain and manual plumbing fixtures were in good condition. The domestic water distribution system is within its recommended useful life. The sanitary waste system is beyond its recommended useful life.

Water heater is in good condition.

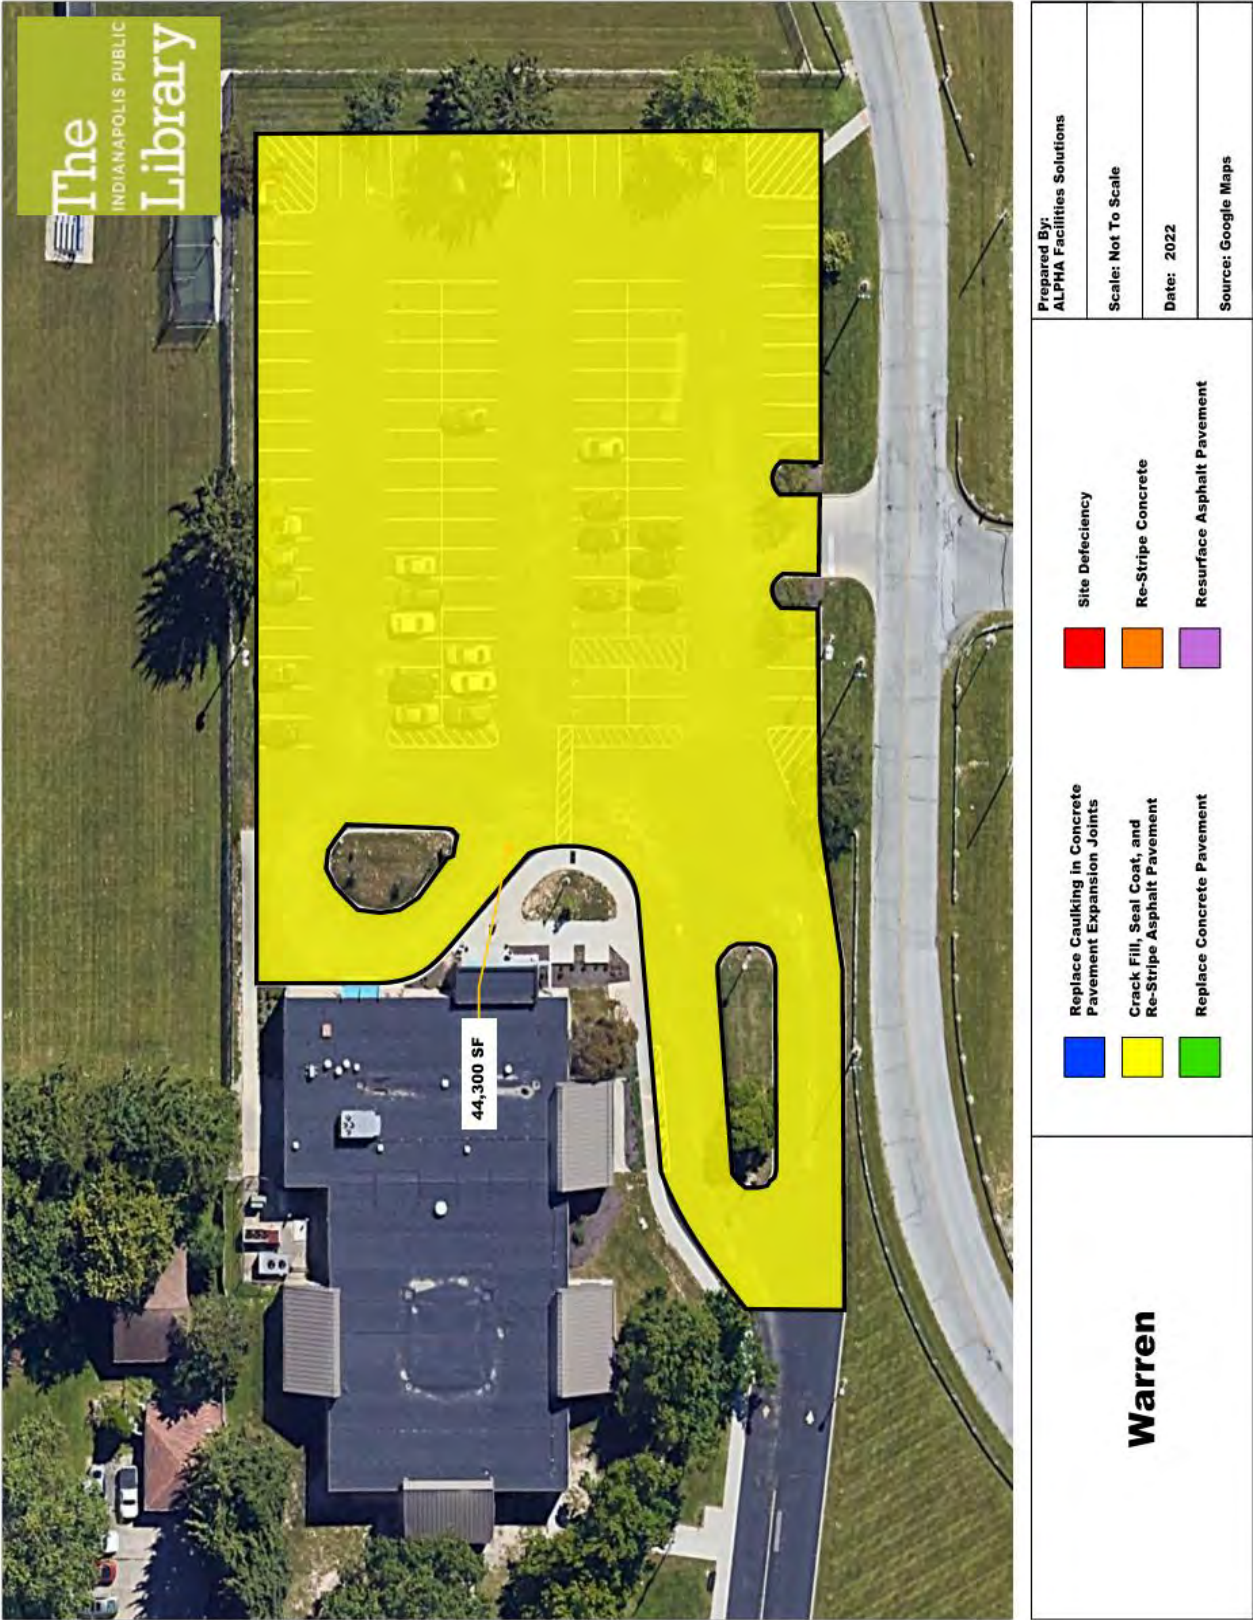
Figure 20. Site and Infrastructure Deficiencies Markup: Warren

Asset Description	Corrective Action	Notes	Priority	Current Needs	Year
Vehicular Pavements	Crack Fill, Seal Coat, and Restripe Asphalt Pavements	44300 SF @ \$1.2 Per SF	Low	\$53,160	2022
			Total 2022 Needs	\$53,160

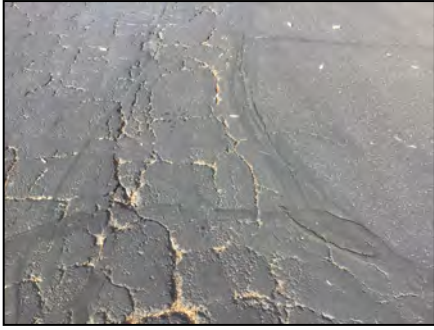
Site Infrastructure

The asphalt pavements were in poor condition and in need of resealing as longitudinal and transverse cracking were observed throughout the pavement.

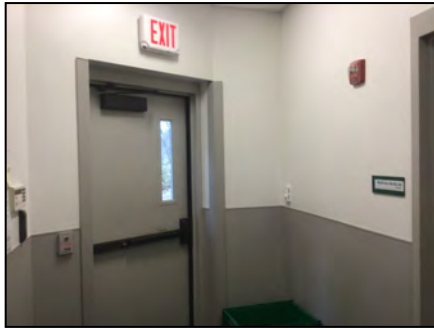
Electrical

The LED lighting was in good condition. The electrical branch wiring is within its recommended useful life. The service and distribution system was in good condition. The emergency and exit lighting is beyond its recommended useful life.

Emergency and exit lighting appear to be recent.
The distribution system is approaching end of life.

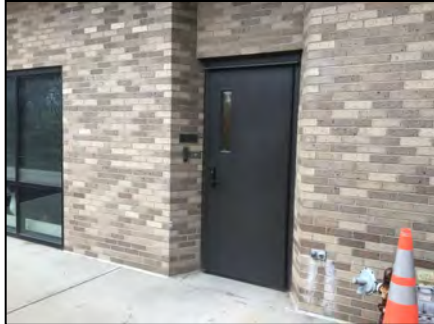
Exterior Enclosure

The metal and glazed doors were in good condition. The double-pane windows were in good condition. The brick veneer walls were in good condition. The asphalt shingle roof covering was within its recommended useful life.

Paint is thin on fascia.

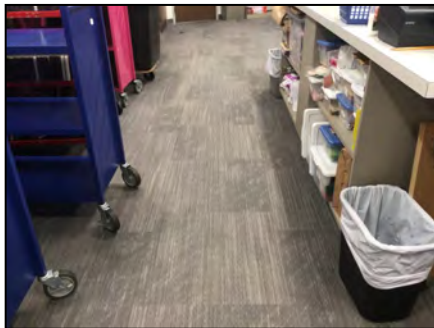
Interiors

The laminate wood, carpet and vinyl tile floor finishes were in good condition. The painted and tile wall finishes were in good condition. The wood and suspended acoustical tile ceiling finishes were in good condition.

Damage to wall by mop sink. Staining on carpet.

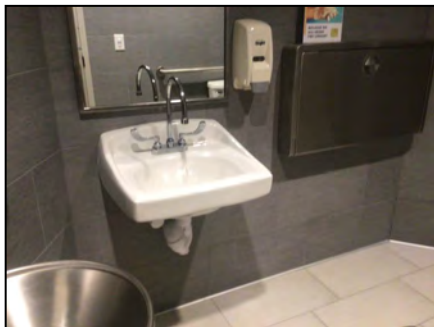
Plumbing

The porcelain and manual plumbing fixtures were in good condition. The domestic water distribution system is within its recommended useful life. The sanitary waste system is within its recommended useful life.

Water heaters are in good condition.
