Facilities Assessment

Facility Condition Assessment

Indianapolis Public Library

February 27, 2023

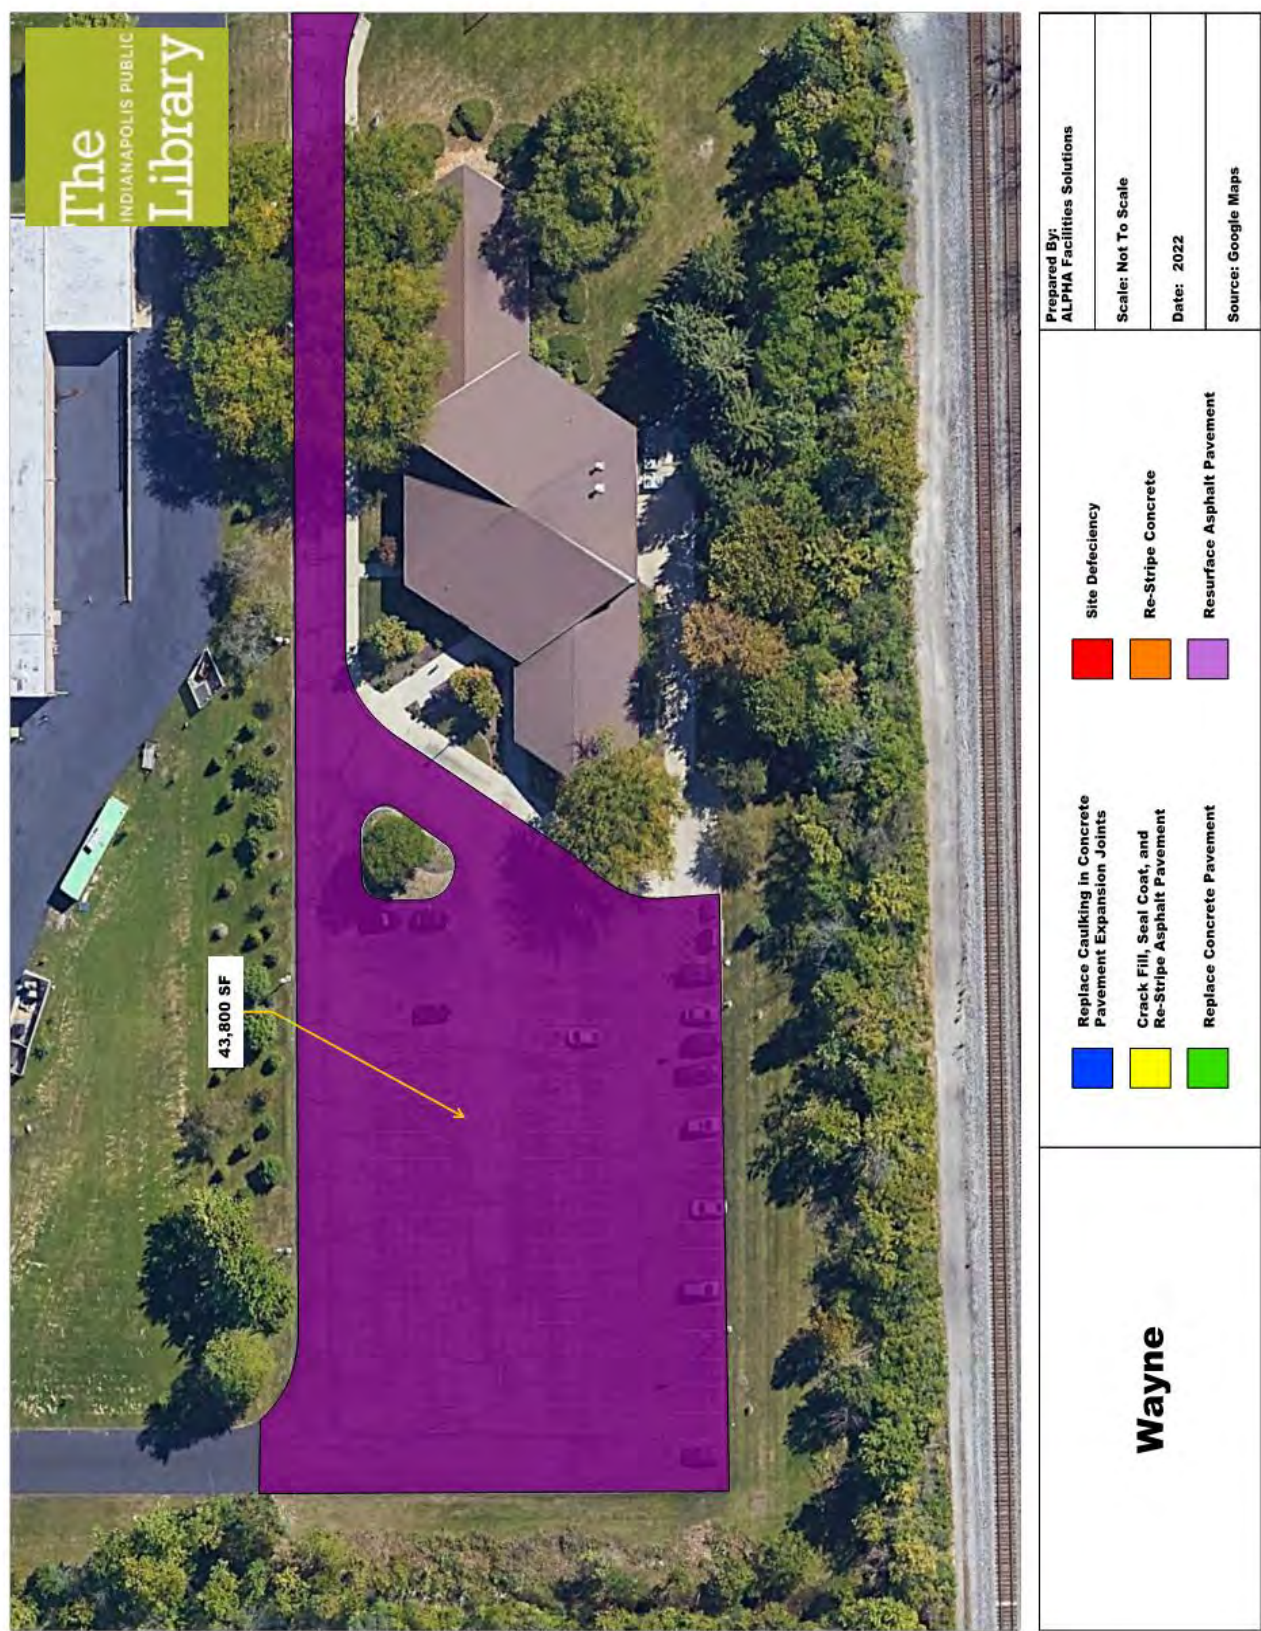
Figure 21. Site and Infrastructure Deficiencies Markup: Wayne

Asset Description	Corrective Action	Notes	Priority	Current Needs	Year
Vehicular Pavements	Resurface Asphalt Pavements	43800 SF @ \$3.5 Per SF	Low	\$153,300	2022
			Total 2022 Needs	\$153,300

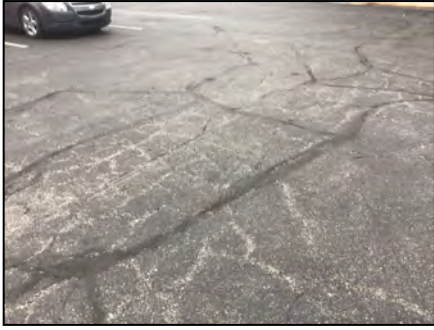
Site Infrastructure

The asphalt pavements were in poor condition and in need of resurfacing as longitudinal cracking, transverse cracking, and degradation were observed throughout the pavement.

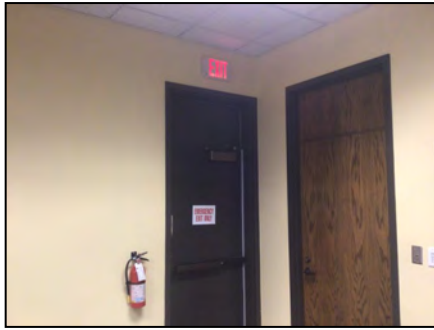
Electrical

The fluorescent lighting was in good condition. The electrical branch wiring is beyond its recommended useful life. The service and distribution system was in good condition. The emergency and exit lighting is beyond its recommended useful life.

There is some retrofit LED lighting in the building.
Age of emergency and exit need to be determined.
There is no fire alarm system in the building.

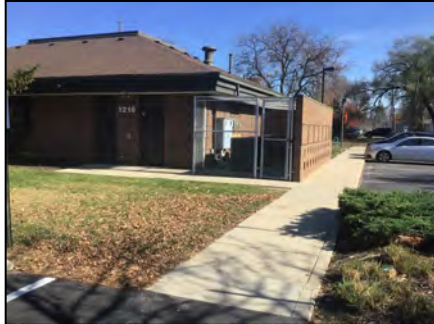
Exterior Enclosure

The glazed doors were in good condition; however, the metal doors were in fair condition due to observed rusted panels. The double-pane windows were in good condition. The brick veneer walls were in good condition. The asphalt shingle roof covering was beyond its recommended useful life.

Tuckpointing needed on screen wall. Much is pile up onto window frame.

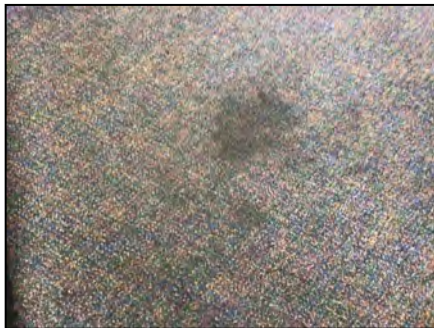
Interiors

The carpet and ceramic tile floor finishes were in fair condition due to observed stains. The vinyl and painted wall finishes were in good condition. The suspended acoustical tile ceiling finishes were in good condition.

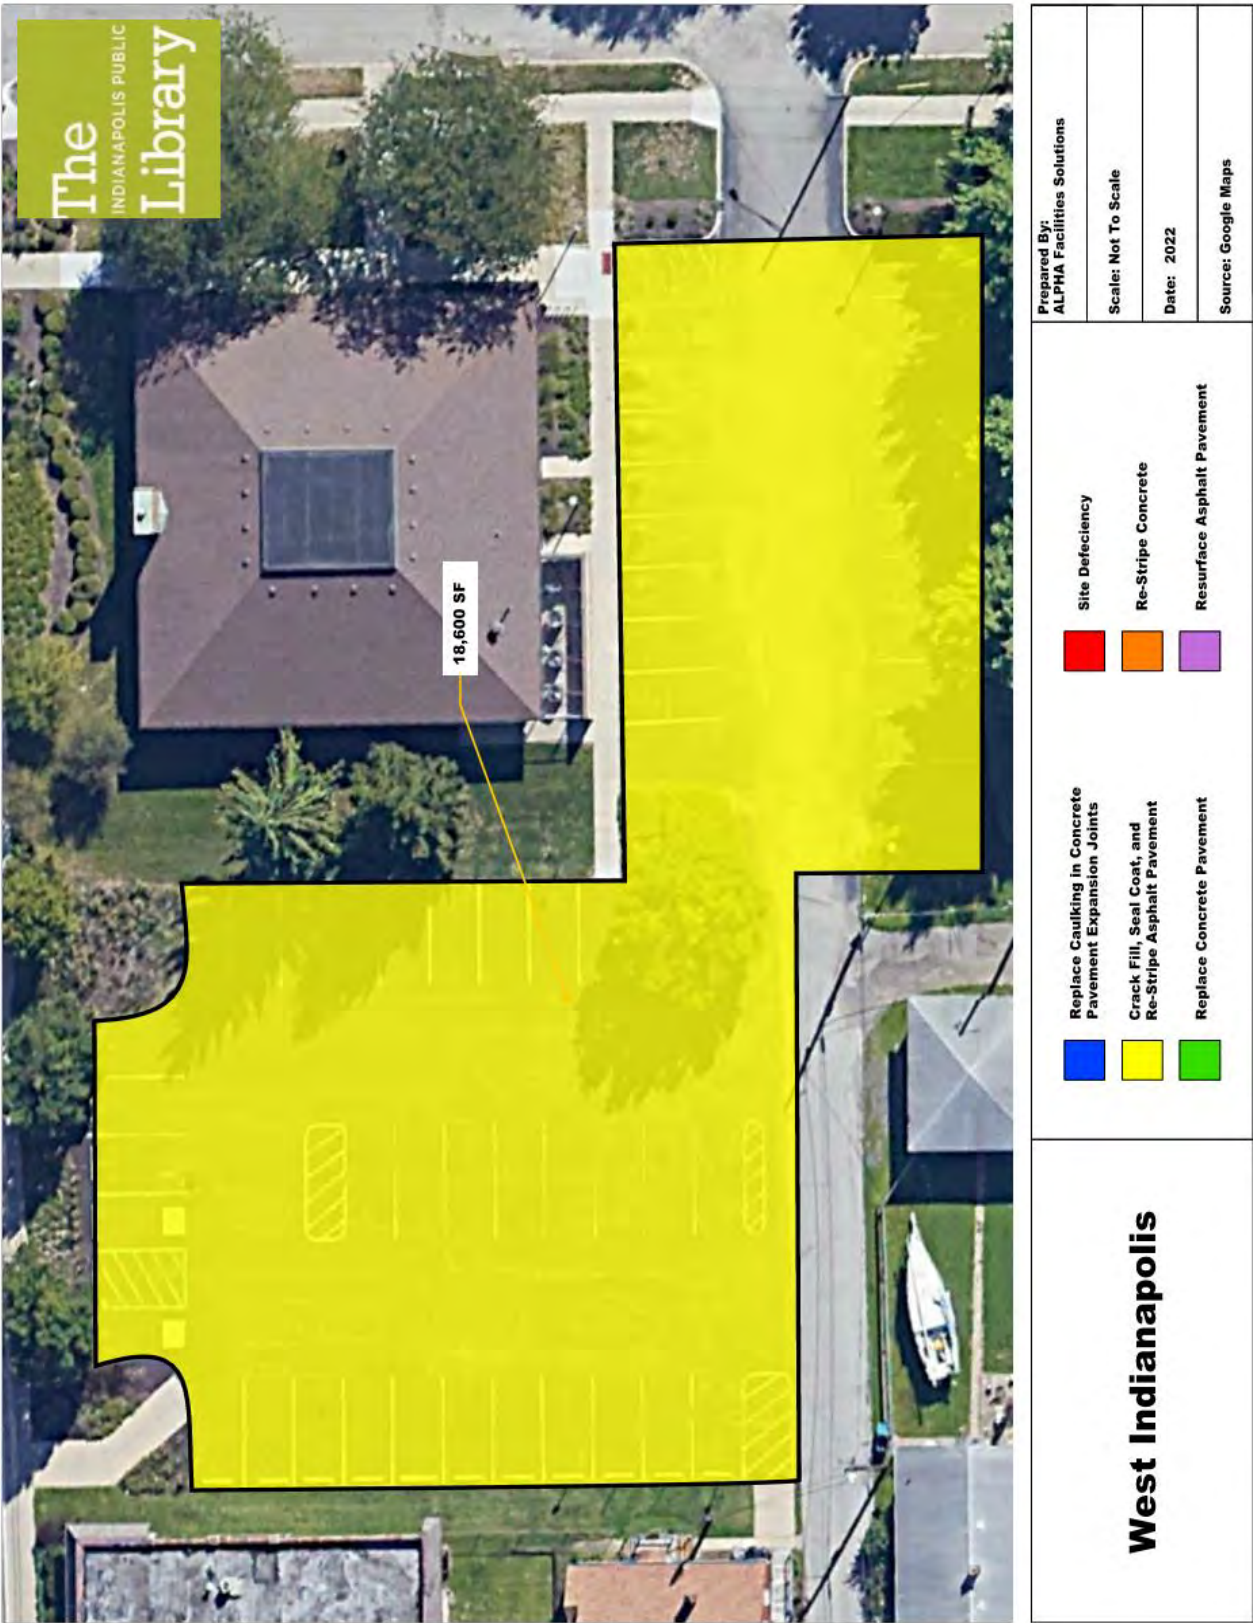
Figure 22. Site and Infrastructure Deficiencies Markup: West Indianapolis

- The asphalt pavements were in poor condition and in need of resealing as longitudinal and transverse cracking were observed throughout the pavement.

Asset Description	Corrective Action	Notes	Priority	Current Needs	Year
Vehicular Pavements	Crack Fill, Seal Coat, and Restripe Asphalt Pavements	18600 SF @ \$1.2 Per SF	Low	\$22,320	2022
			Total 2022 Needs	\$22,320

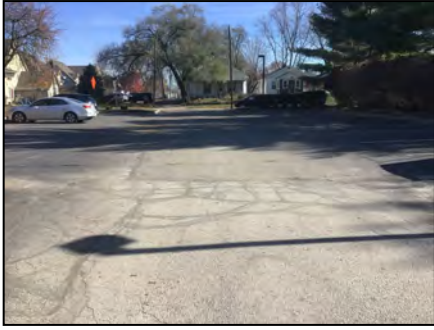
Site Infrastructure

The asphalt pavements were in poor condition and in need of resealing as longitudinal and transverse cracking were observed throughout the pavement.

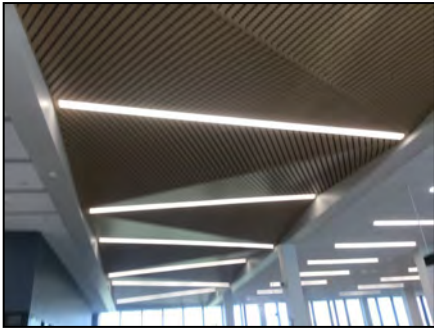
Electrical

The LED lighting was in good condition. The electrical branch wiring is within its recommended useful life. The service and distribution system was in good condition. The emergency and exit lighting is within its recommended useful life.

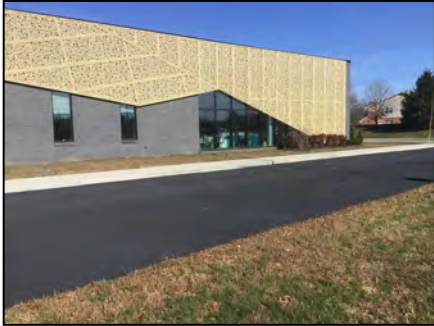
Exterior Enclosure

The glazed and metal doors were in good condition. The double-pane windows were in good condition. The brick veneer walls were in good condition. The modified bitumen roof covering was within its recommended useful life.

Roofing is TPO. Slip sheets have shifted from under solar panel ballasts.

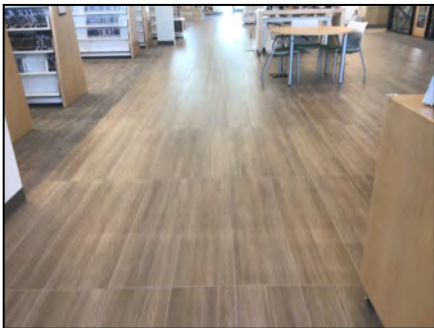
Interiors

The ceramic tile, carpet and laminate wood floor finishes were in good condition. The painted wall finishes were in good condition. The metal strips, suspended acoustical tile and painted ceiling finishes were in good condition.

LVT and carpet tile are curling at the edges. Some stains on carpet and toilet partitions.

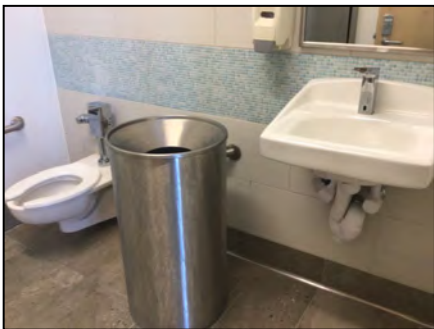
Plumbing

The porcelain and automated plumbing fixtures were in good condition. The domestic water distribution system is within its recommended useful life. The sanitary waste system is within its recommended useful life.
